Longview Estates Development

Lahardane, Ballyvolane, Cork

Stage 1/2 Road Safety Audit

November 2019

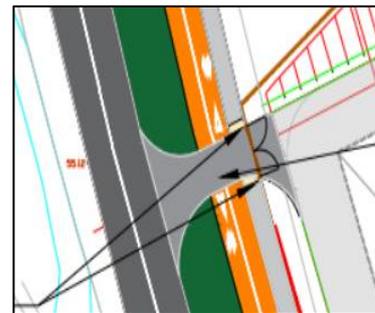
Figure 2.1

2.2.1 Problem 3: Unsafe Pedestrian/Cyclist Crossing Detail at J1

Priority has been given to vehicles at the point where the cycle/pedestrian facility passes the entrance to the proposed pump station. Failure to provide an appropriate crossing point with priority for vulnerable road users on a ped/cycle facility may lead to pedestrians/cyclists/ or visually/mobility impaired users misinterpreting priority at junctions resulting in collisions with entering and exiting vehicles. Refer to Figure 2.1.

Recommendation 3

Provide a raised entry treatment with appropriate tactile paving at the crossing point in accordance with the relevant guidelines.

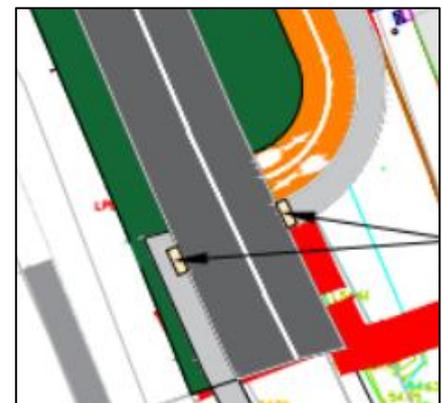
Figure 2.2

2.2.2 Problem 4: Unsafe End of Cycle-Track & Crossing

No warning has been provided to motorists of the pedestrian/cyclist crossing facility and no warning has been provided to cyclists of the termination of the cycle facility. The lack of a Stop or yield road markings for the cycle facility may lead to incorrect assumptions of priority. The potential for vehicle/cyclist or vehicle/pedestrian collisions is high, particularly given the historical collision statistics. See Figure 2.2.

Recommendation 4

Provide the appropriate signage and road marking at and in advance warning of the cycle lane ending and crossing point in accordance with the relevant standards and guidelines.

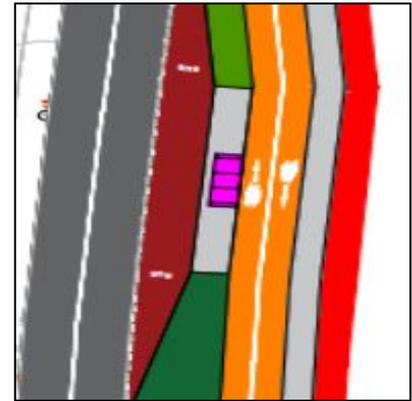
2.3.1 Problem 5: Poor Pedestrian Access to Bus Stop

The bus stop is segregated from the footpath by a two-way cycle facility, essentially creating an “island bus stop”. Failure to provide an appropriate crossing detail with signage/markings and tactile paving to inform cyclists of the possibility of pedestrians crossing their path could lead to collisions between pedestrians and cyclists at this location. Refer to Figure 2.3.

Recommendation 5

Provide the appropriate markings/signage and tactile paving to inform all users about a shared surface at this location in accordance with the NTA National Cycle Manual. *Figure 2.3*

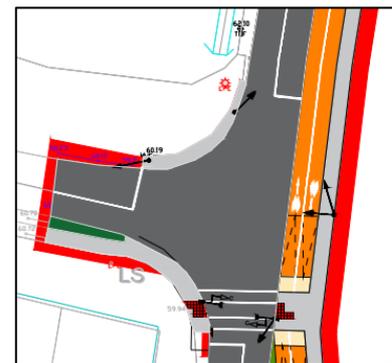
2.3.2 Problem 6: Incorrect Tactile Paving Arrangement

The tactile paving arrangement shown at the proposed signalled junction as shown in Figure 2.4 is incorrect. The leg extending away from the road edge should be on the approaching traffic side and it should extend to the back of the footpath. Failure to provide tactile paving to the recommended layouts could lead to confusion for the visually impaired Resulting in potential collisions with passing vehicles.

2.3.3 Problem 7: Inadequate Pedestrian Crossing Width

The width of the proposed crossing is not defined on the drawings. As it is envisaged that both cyclists and pedestrians will want to cross the R614 at this location and the signal aspect diagram indicates same, however there doesn't appear to be adequate width to accommodate both pedestrians and cyclists. Failure to provide appropriate crossing width could lead to collisions between pedestrians and cyclists. Refer to Figure 2.4 above

2.3.4 Problem 8: Unsafe Off Road Cycle Track

The two-way raised off road cycle track from J2 to J3 introduces a contraflow cycle facility arrangement for uphill cyclists, with no protection other than the raised kerb. There is potential for an uphill cyclist (northbound) to wobble out onto the downhill trafficked carriageway with potential for serious vehicle/cycle collisions. As the height of the raised facility is unclear, the higher the kerb the more serious the consequences of a fall from the kerb. See Figure 2.4.

2.3.5 Problem 9: Traffic Signal Pole Arrangement

There appears to be no primary signal head on the left hand side at carriageway level for traffic approaching from the north towards the proposed signalised junction as per Figure 2.4 above. Failure to provide the appropriate signal heads could lead to vehicles being unable to see the traffic signals in advance of the stop line and misinterpreting priority at the junction and leading to collisions with traffic approaching from the Kilbarry Link road. There is also potential for rear end shunt collisions as drivers become aware of the signal control when it is too late to decelerate over a safe distance.

Recommendation 6

Provide the appropriate tactile paving design to inform all road users about the controlled crossing location and form in accordance with the relevant guidelines.

Recommendation 7

Provide the appropriate crossing width that will incorporate both pedestrians and cyclists in accordance with the relevant guidelines. A combined pedestrian/cyclist facility should normally have a minimum width of 4.0m.

Recommendation 8

Provide protection to the cyclists by provision of a barrier between the cycle track and the road or green space similar to between J1 and J2 further south.

Recommendation 9

Review the existing Traffic Signals layout in accordance with the relevant guidelines. Consider use of high level cantilever poles for the northern approach.

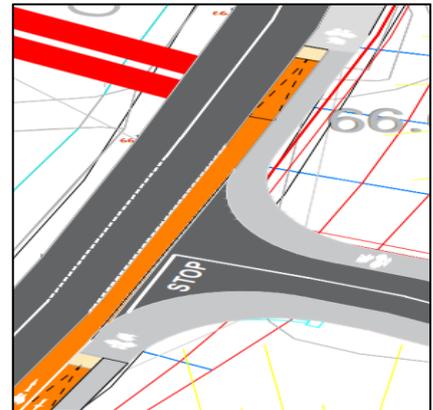
Figure 2.5

2.4.2 Problem 11: No Pedestrian Crossing at entrance to Development

No provision has been made for pedestrians to cross at the entrance to the development. Failure to provide an appropriate crossing point may lead to pedestrians and or visually impaired users misinterpreting priority at junctions resulting in collisions with entering and exiting vehicles. Refer to Figure 2.5.

Recommendation 11

Provide an appropriate crossing point for pedestrians and all vulnerable road users in accordance with the relevant guidelines. A raised entry treatment should be considered.

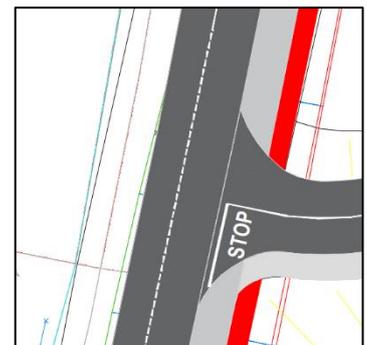
Figure 2.6

2.5.1 Problem 12: No Pedestrian Crossing at entrance to Development

No provision has been made for pedestrians or cyclists to cross at the entrance to the development. Failure to provide an appropriate crossing point may lead to pedestrians or visually impaired users misinterpreting priority at junctions resulting in collisions with entering and exiting vehicles. Refer to Figure 2.6. Refer to Figure 6.

Recommendation 12

Provide the appropriate crossing point for pedestrians, cyclists, mobility impaired and visually impaired users in accordance with the relevant guidelines.

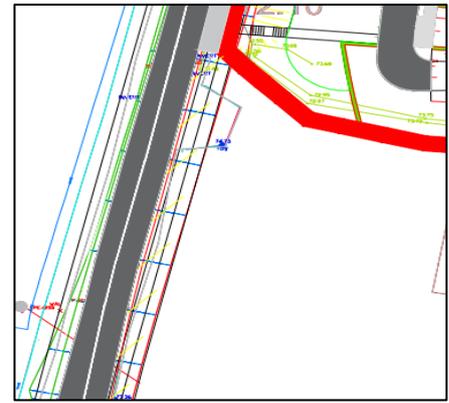
Figure 2.7

2.5.2 Problem 13: Lack of Footpath connectivity

The footpath/shared surface along the R614 is terminated at approximately 70m south of Junction 4 for a distance of 100m. Failure to provide footpath connectivity along a road will force vulnerable road users to enter the trafficked carriageway leading to potential collisions with passing vehicles. Refer to Figure 2.7.

2.6.1 Problem 14: No Pedestrian Crossing at entrance to Development

No provision has been made for pedestrians or cyclists to cross at the entrance to the development. Failure to provide an appropriate crossing point may lead to pedestrians or visually impaired users misinterpreting priority at junctions resulting in collisions with entering and exiting vehicles. Refer to Figure 2.7.

Recommendation 13

Ensure that footpath connectivity is provided throughout the extent of the scheme works.

Recommendation 14

Provide the appropriate crossing point for pedestrians and or visually impaired users in accordance with the relevant guidelines.

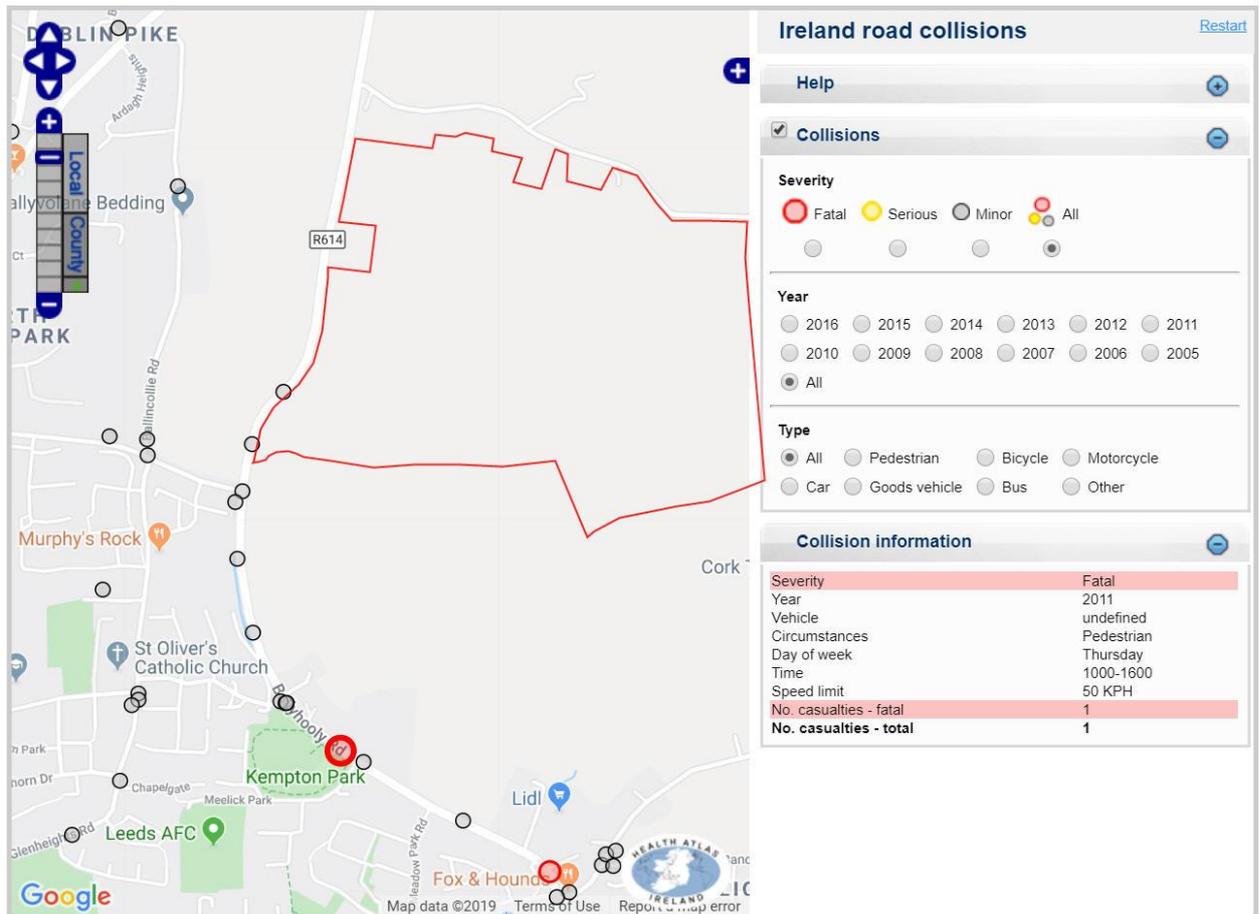
RSA Collision Statistics on Local Road Network in the vicinity of the Site

No specific Road Collision data was provided to the audit team. The auditors reviewed the RSA Road Collision Statistics, in the vicinity of the applicant site. Ten minor traffic collisions were reported in the period 2005 – 2016 and one fatal traffic collision was reported in 2011.

There are a lot of collisions along the stretch of road between proposed junctions J1 and J3. The nature of the collisions suggest a pattern of higher than safe vehicular speeds. The curving alignment also restricts forward sight distance and the transition from rural to urban is not well defined.
