HOLLYSTOWN KILMARTIN SITE 4

ENVIRONMENTAL IMPACT ASSESSMENT REPORT (EIAR) VOLUME 3 : APPENDICES

6733_RPEIA01_Environmental Impact Assessment Report (EIAR) Volume 3 : Appendices

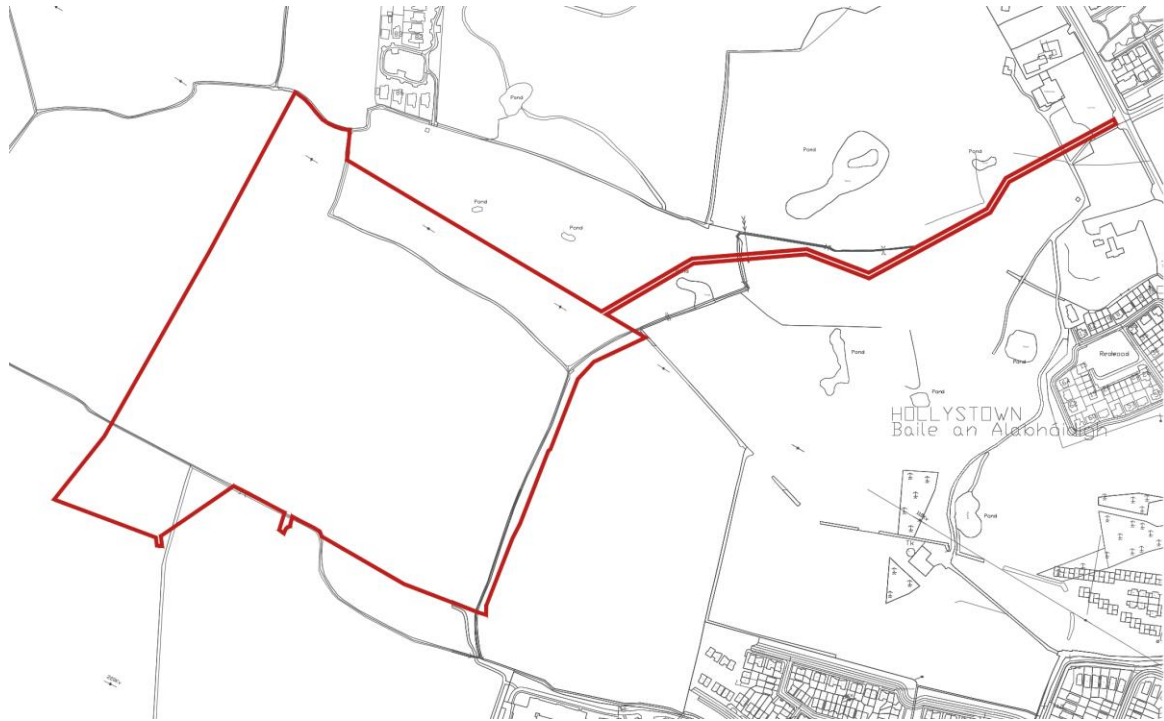
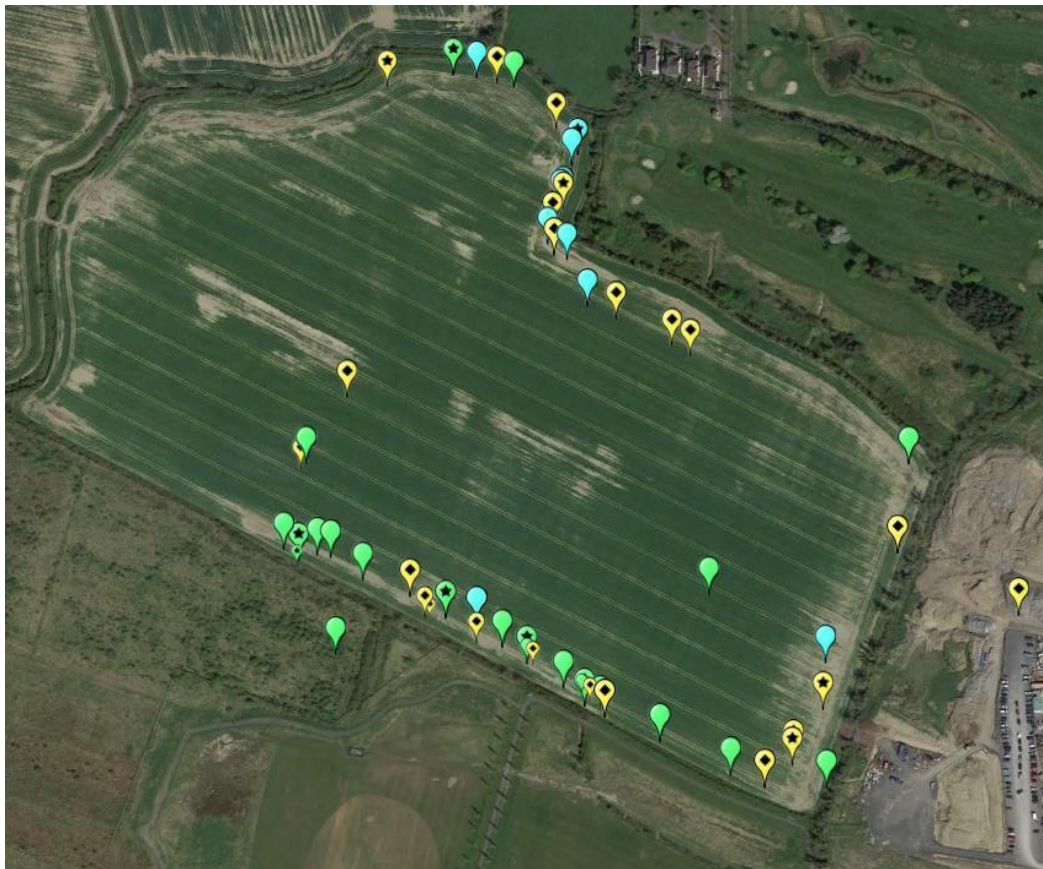
Proposed site and Bat Activity 26th to 27th July 2022

The Leisler's bat total was due to the repeat activity of this species along the southern boundary with the cricket club. Bats flew below tree top height on occasion as well as flying high up over the site. Common pipistrelles were much more notable in the southern section of the field and were primarily noted along the hedgerow to the rear of the Cricket Club.

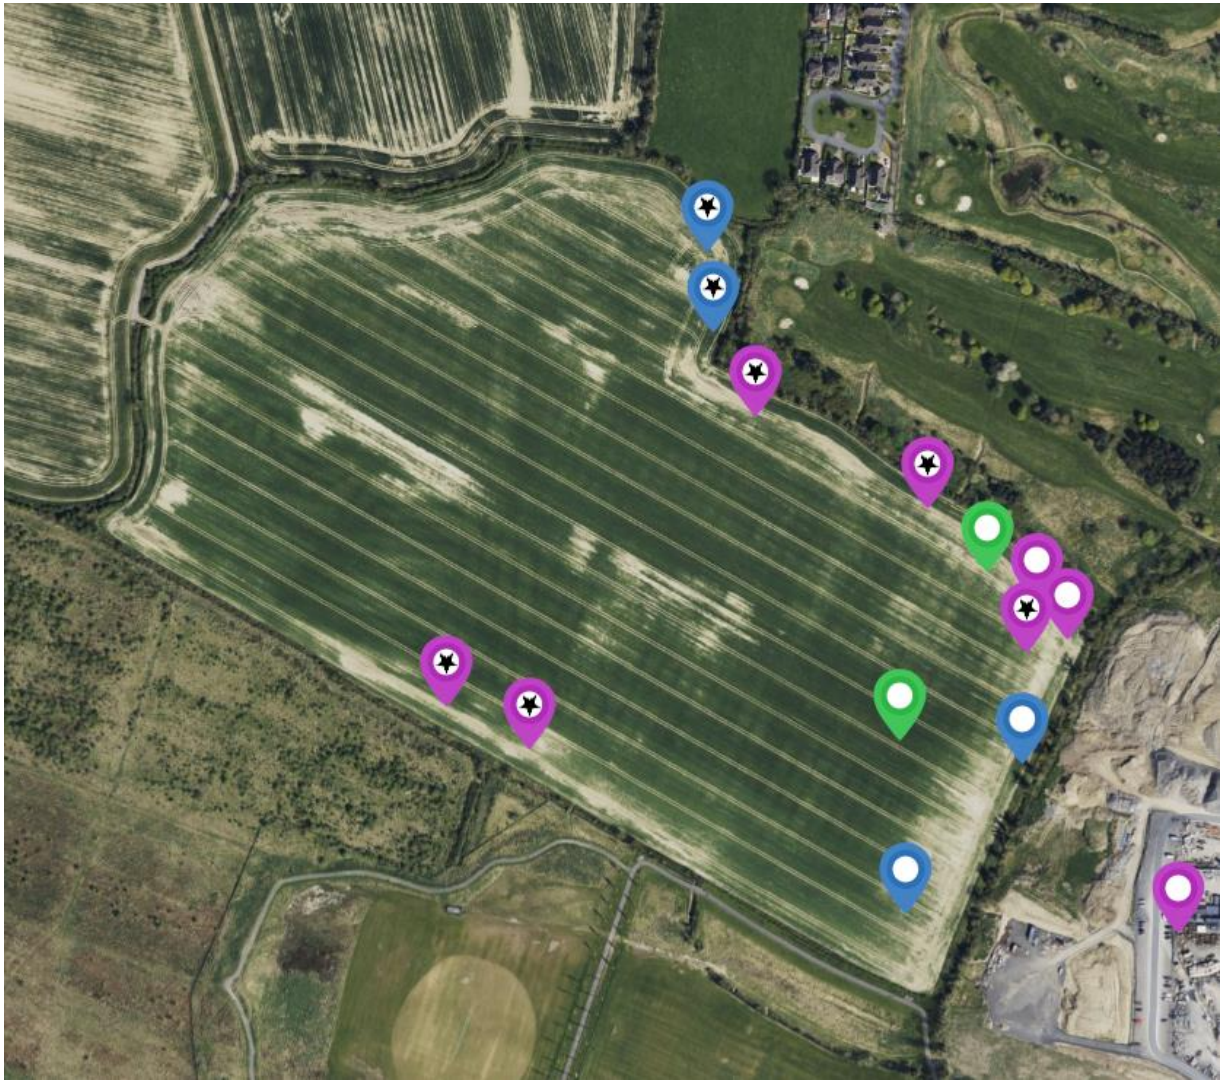
Bat Activity 3rd to 4th August 2023

Leisler's bats appeared to be more active towards the north of the site on this occasion (which may be related to the increased tree cover to this side) while the southern part of the site had a more even balance of species. Immediately prior to dawn, much more activity was observed in the northern portion of the site (especially along the hedge) compared to the southern portion, which may also be an effect of the increased tree cover to the north.

The number of common pipistrelle passes recorded by the static monitor, placed midway along the eastern field boundary, indicates that this hedge is an important feeding and commuting route for this species – as with the large number of Leisler's bat passes recorded during the 2022 survey, this mostly represents repeated passes by the same bats flying back and forth along the length of the hedge while feeding. As no common pipistrelles were recorded immediately before sunrise, these bats were likely to be roosting further from the survey area and had already left the site by that time (with the last common pipistrelle record on the static monitor being at 04:05 hours). Very little bat activity was recorded in the middle of the field at any point over the night.

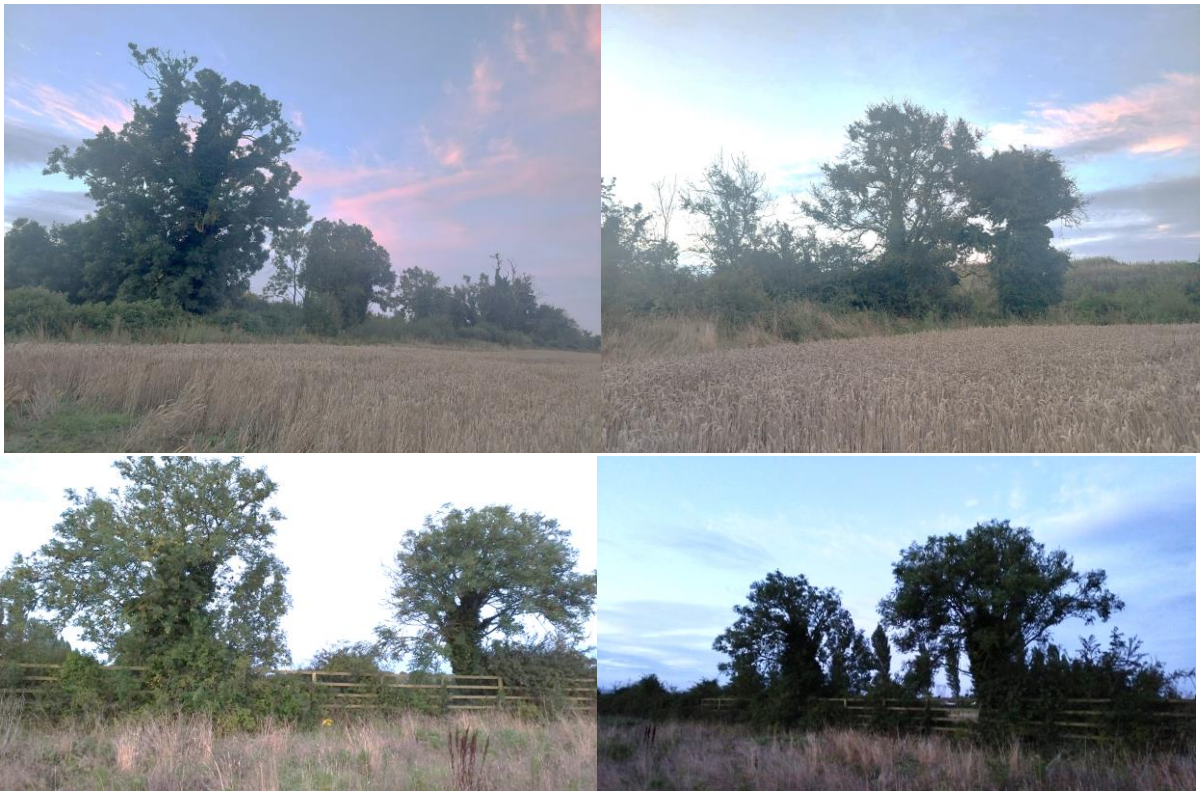
Photographs showing trees along the northern, eastern and southern hedgerows.

While several of these trees are mature enough to have roost potential, all were covered with climbing plants such as ivy which would greatly reduce their potential.

While no tree roosts were noted during this assessment, there is potential that bats may avail of the existing trees for short-term periods (e.g. individual bats may roost overnight). Tree roosts are much more difficult to pinpoint than building roosts due to their frequently short-term use. This is potentially a long-term moderate negative impact without the implementation of mitigation. There are few high-quality trees within the boundary of the site and there is no roost loss identified from this assessment.

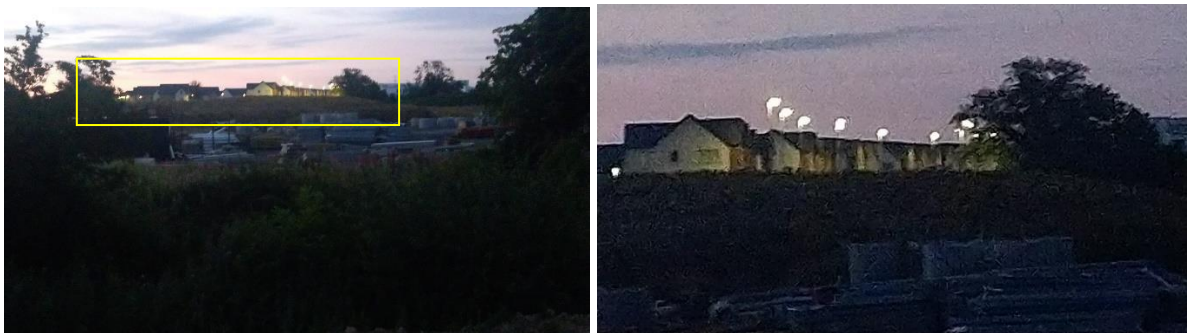
Lighting in new housing south-east of the site (zoomed up to the right)

At present, the site is an unlit field with no light overspill entering from housing albeit that the neighbouring fields are under construction and will be a site for housing within months. Lighting will be introduced for two different functions: 1) Access and safety 2) Security and policing. The former is to allow ease of use at night while the latter ensures a perceived higher security level.

Lighting may affect bat species, in particular, light-intolerant bat species during foraging and if directed at emergence points would affect all bat species, even those that will feed in illuminated areas. This is a long-term moderate negative impact without the implementation of mitigation.

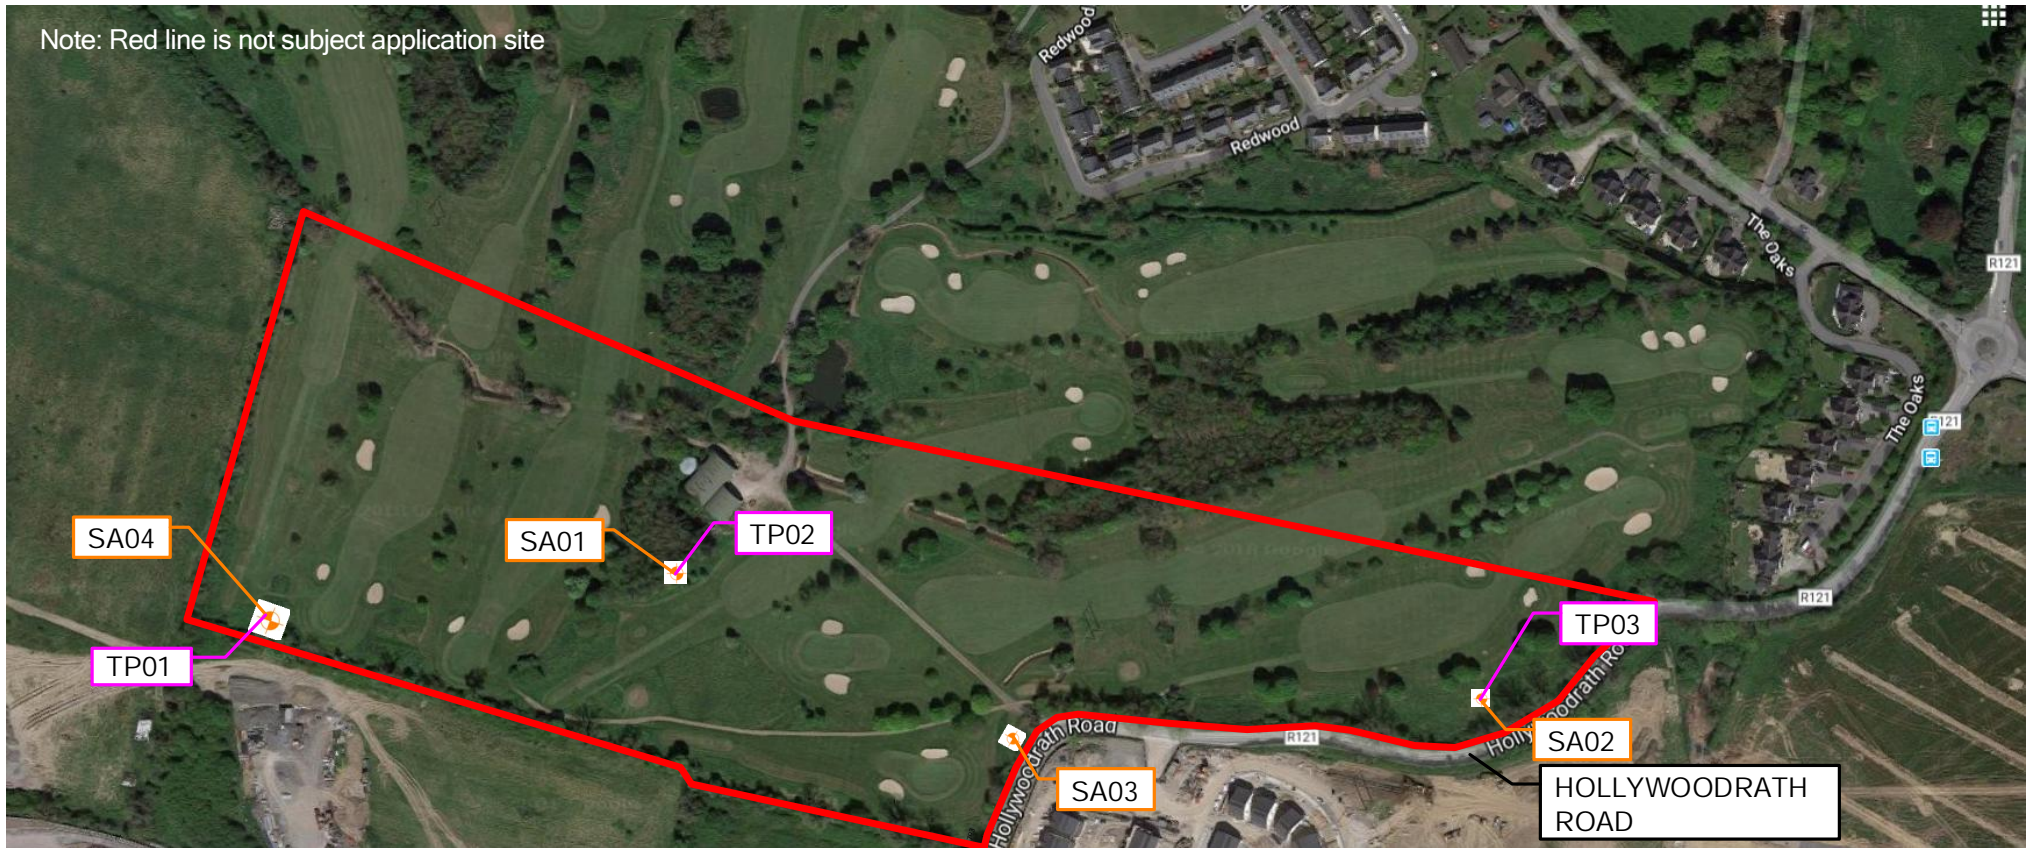
LOCATION: HOLLYSTOWN GOLF COURSE, CO. DUBLIN

TEST TYPE	TEST NUMBERING RANGE	NO. OF TESTS
Soakaways	SA01 - SA04	4
Trial Pit	TP01 - TP03	3

The soakaway testing was carried out the trial pit at the location shown in the exploratory hole location plan in Appendix 1. The pit was carefully excavated and filled with water to assess the infiltration characteristics of the proposed site. The pit was allowed to drain and the drop in water level was recorded over time as required by BRE Digest 365. The pit was logged prior to completing the soakaway test and was backfilled with arising's upon completion. The soakaway test result is provided in Appendix 4 of this Report.

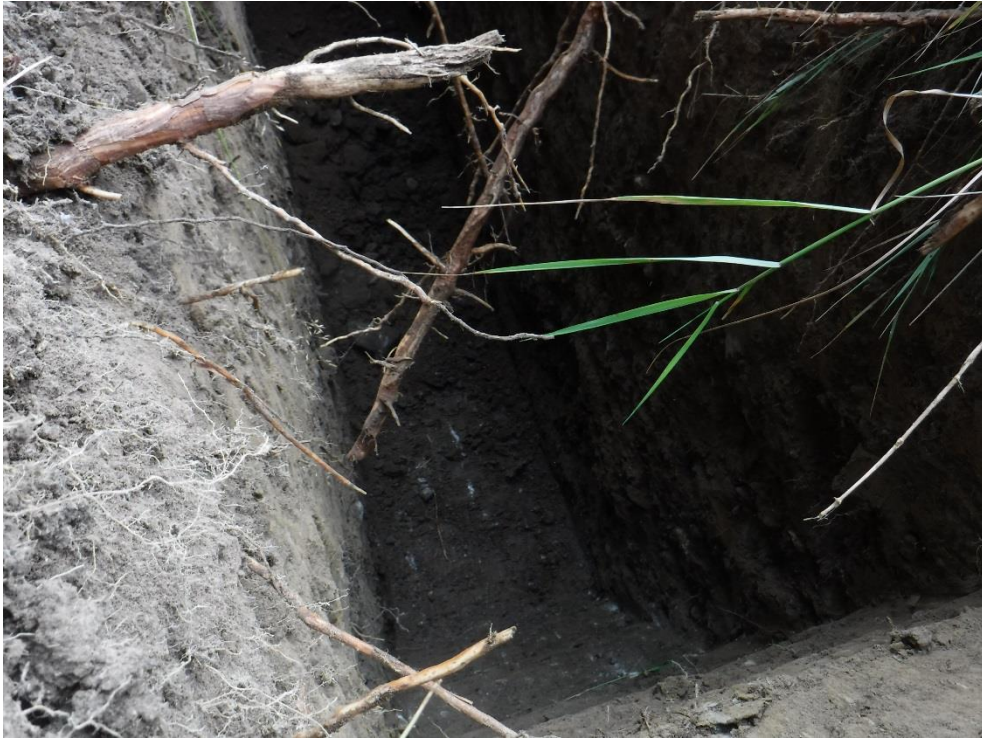
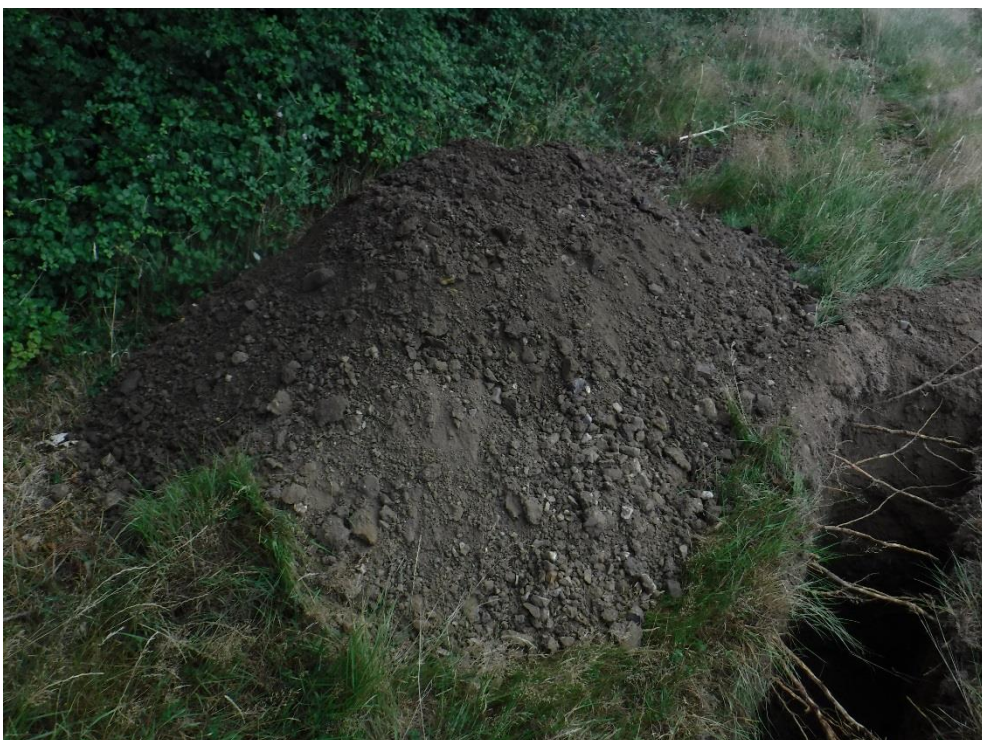
SA01

Hollystown Golf Course – Trial Pit Photographs

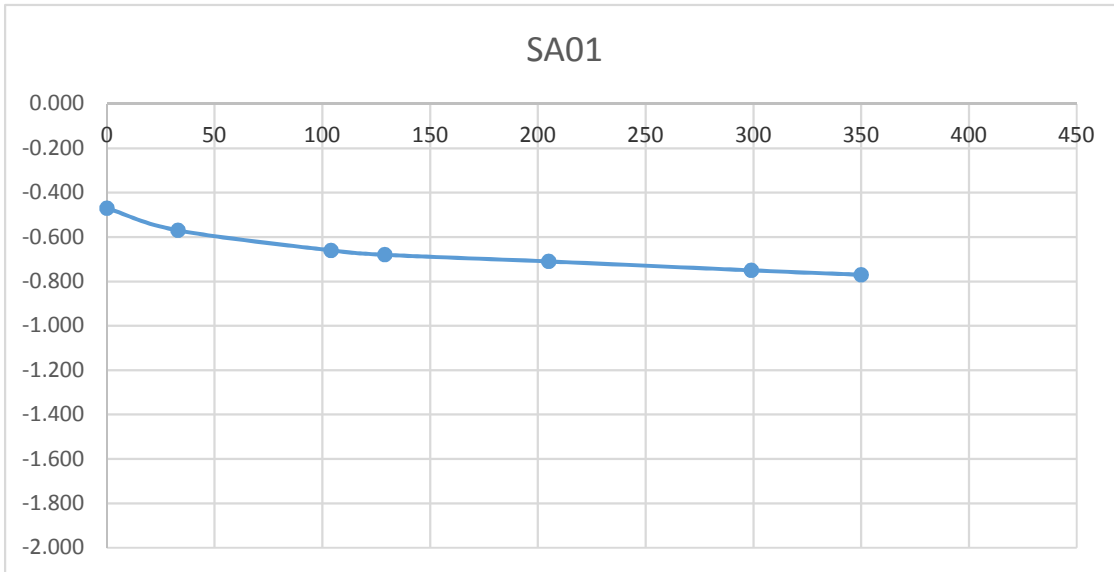
Start depth	Depth of Pit	Diff	75% full	25%full
0.47	1.500	1.030	0.7275	1.2425

Soakaway Test to BRE Digest 365

Infiltration rates of 1.980×10^{-6} and 1.955×10^{-6} m/s respectively were calculated for the soakaway locations SA02 and SA03. At the locations of SA01 and SA04 the water level dropped too slowly to allow calculation of 'f' the soil infiltration rate. These locations are therefore not recommended as suitable for soakaway design and construction.

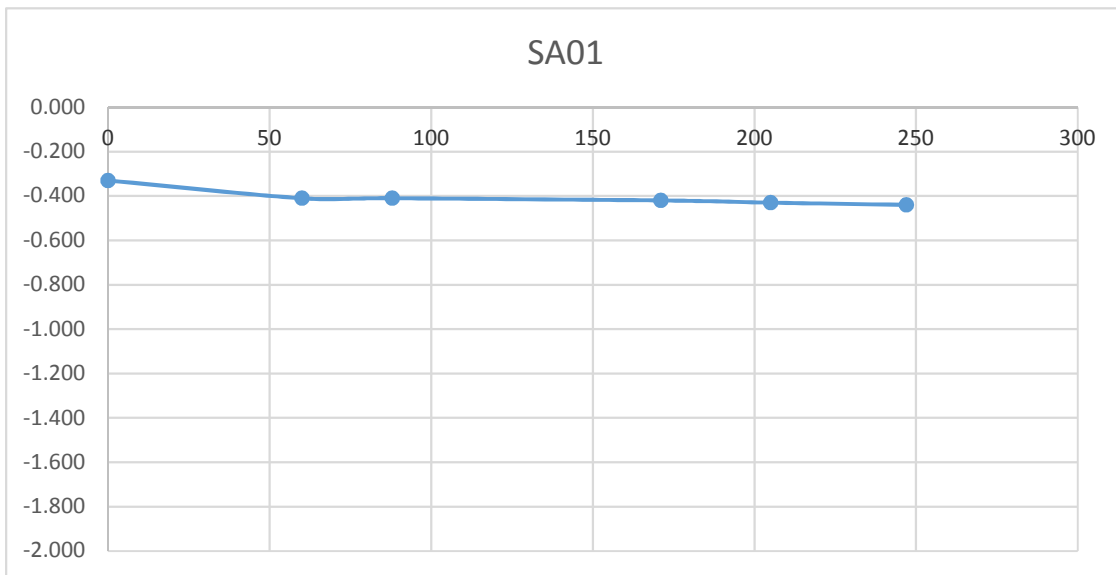
Date	Time	Water level (m bgl)
02/08/2018	0	-0.330
02/08/2018	60	-0.410
02/08/2018	88	-0.410
02/08/2018	171	-0.420
02/08/2018	205	-0.430
02/08/2018	247	-0.440

*Soakaway failed - Pit backfilled				
Start depth	Depth of Pit	Diff	75% full	25%full
0.33	1.600	1.270	0.6475	1.2825

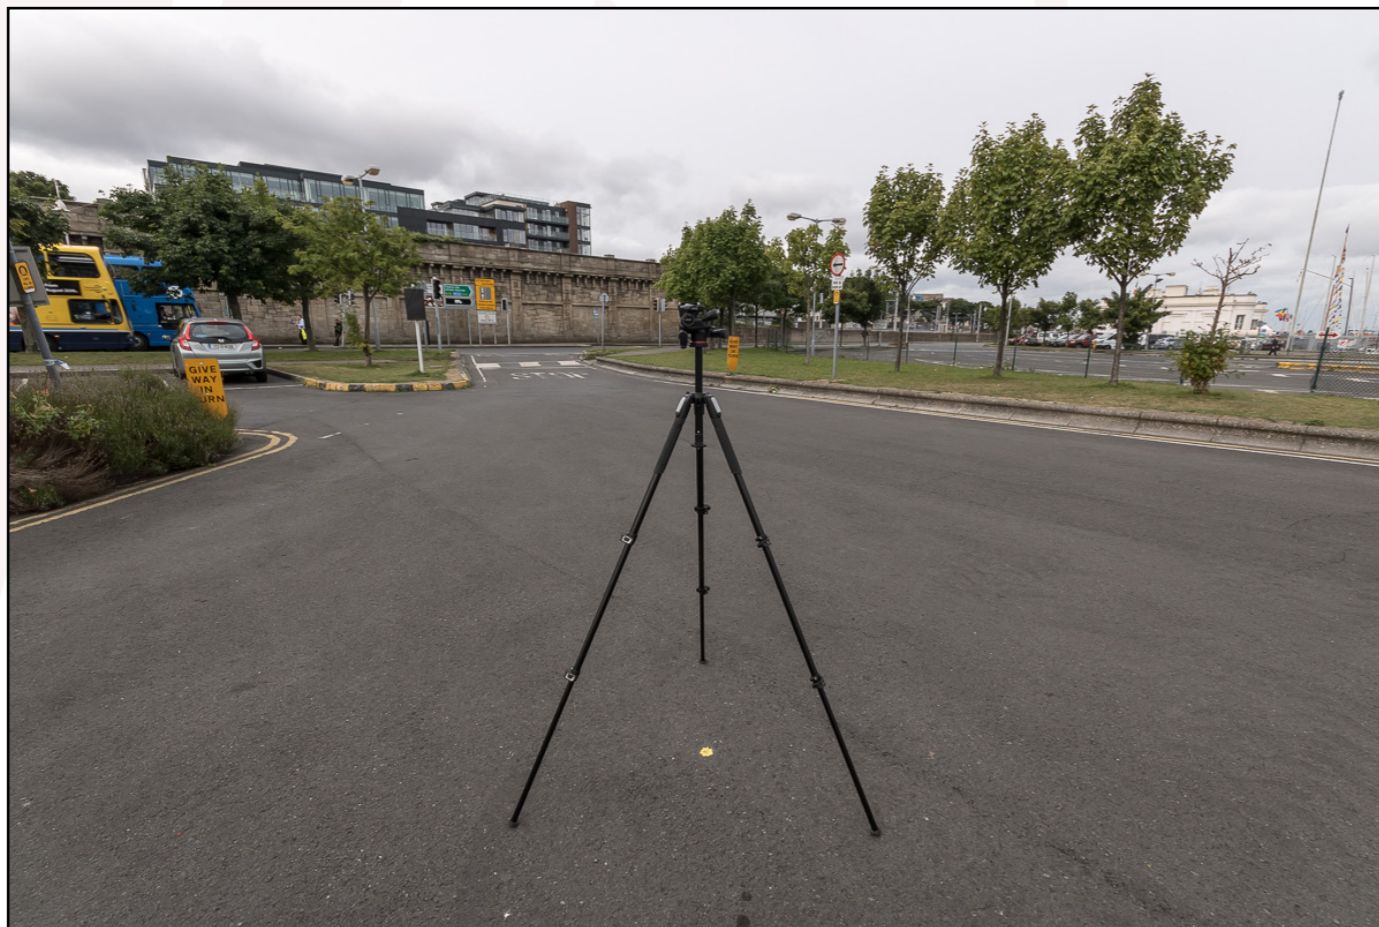
Fig.1: Camera Location marked and photographed.

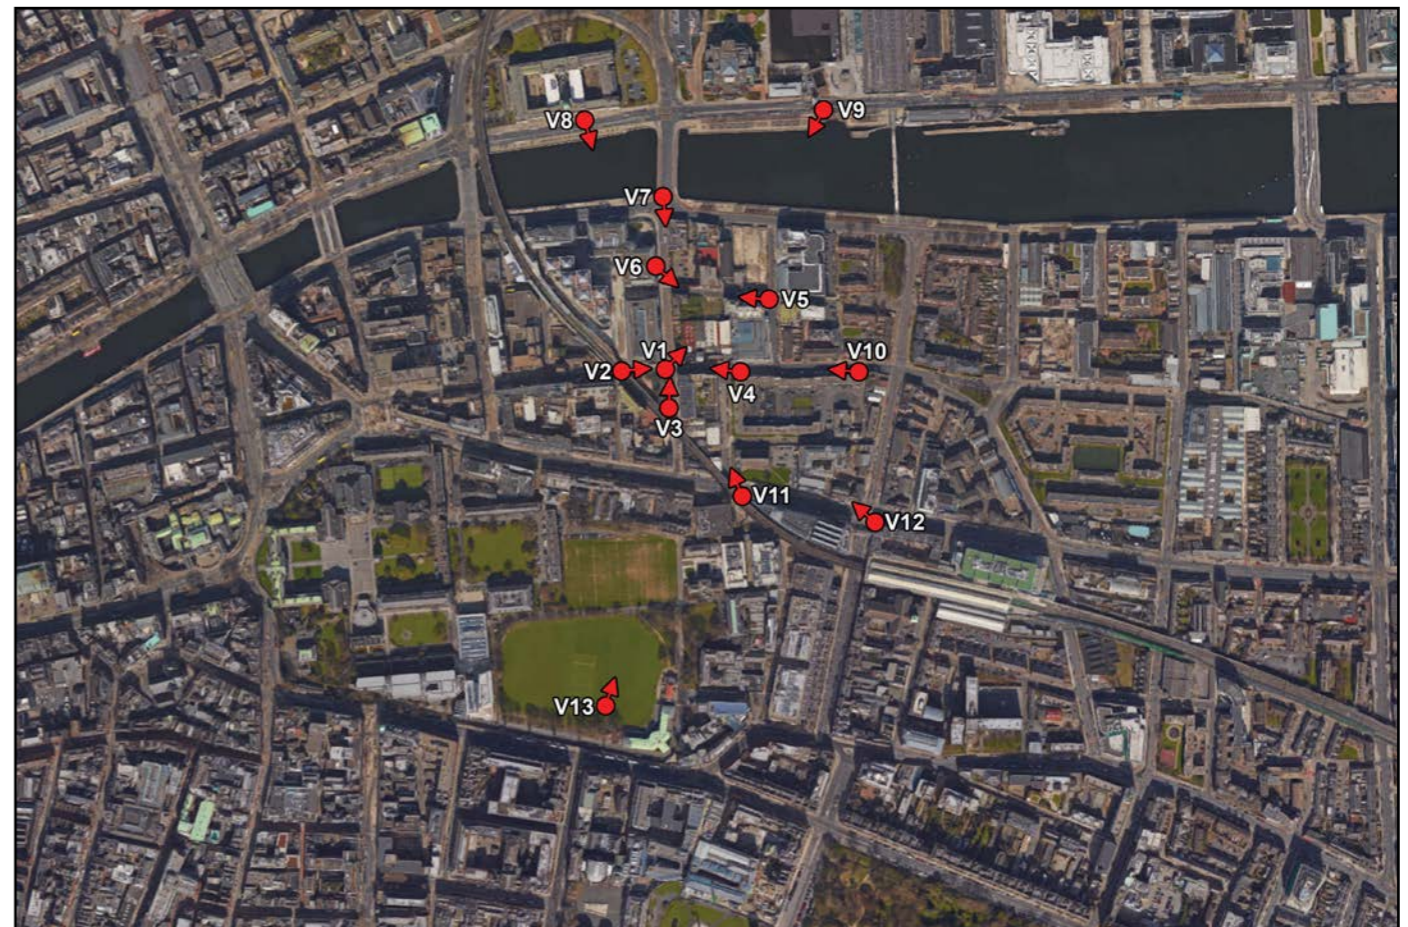
Fig.2: Viewpoint location map post site visit.

All photographs go through post processing back in the studio. The full set of photos along with a viewpoint location map (Fig 2 below) are issued to the client for review and to choose the best shots that will demonstrate the visual impact that the proposed scheme may/may not have. For each photo at each location, two focal lengths will be issued – the 50mm option and a wider field of view option. The most appropriate shot will be chosen depending on the surrounding context and location of the shot. See earlier section 3.2 for further explanation.

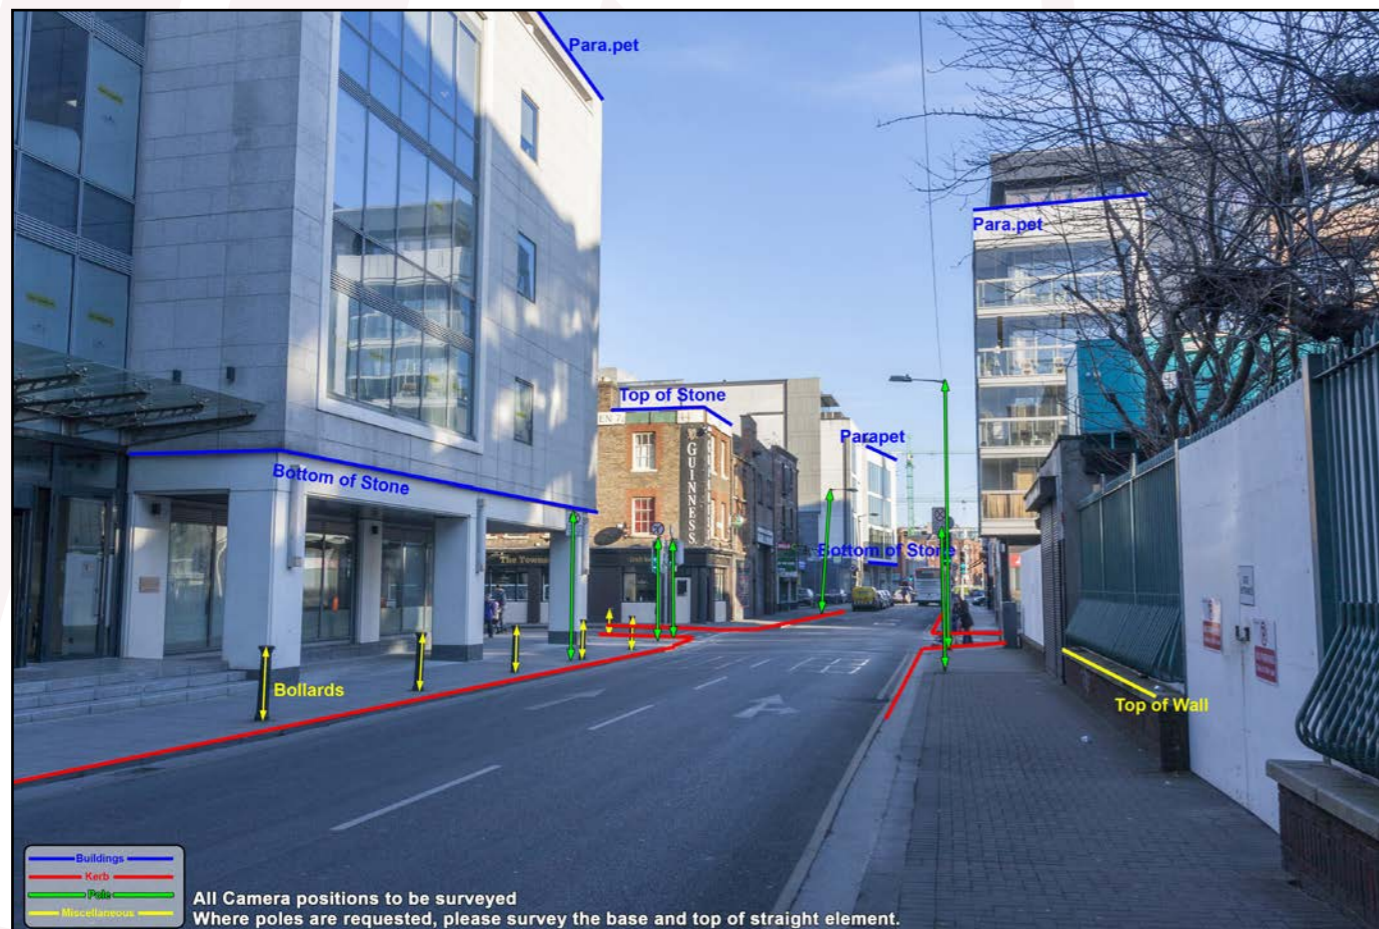
Fig.7: Fixed reference points marked for surveyour.

The survey team records the camera/tripod position using GPS and Total Station to an accuracy of +/-1cm Northing and Easting and to an accuracy of +/- 2cm Elevation. The 'marked up' fixed reference points identified in each photo are then surveyed to establish exact orientation of the view and to verify the photomontage process. (Fig 8 below). This survey data is later modelled and included in the digital 3D model of the proposed development. (See section 3.4)

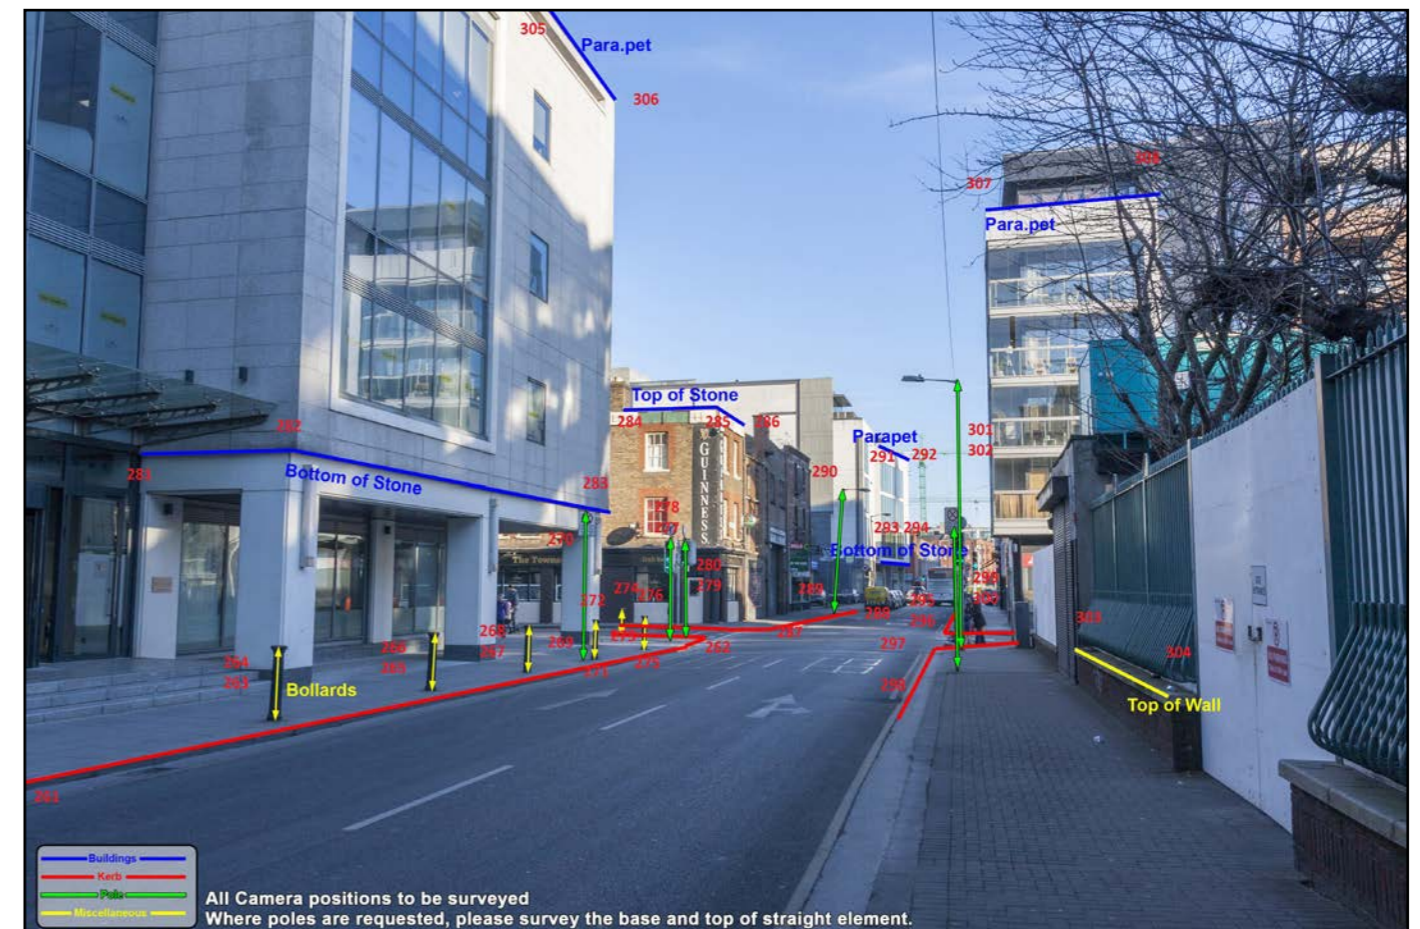
Fig.8: Fixed reference points surveyed and numbered by surveyor.

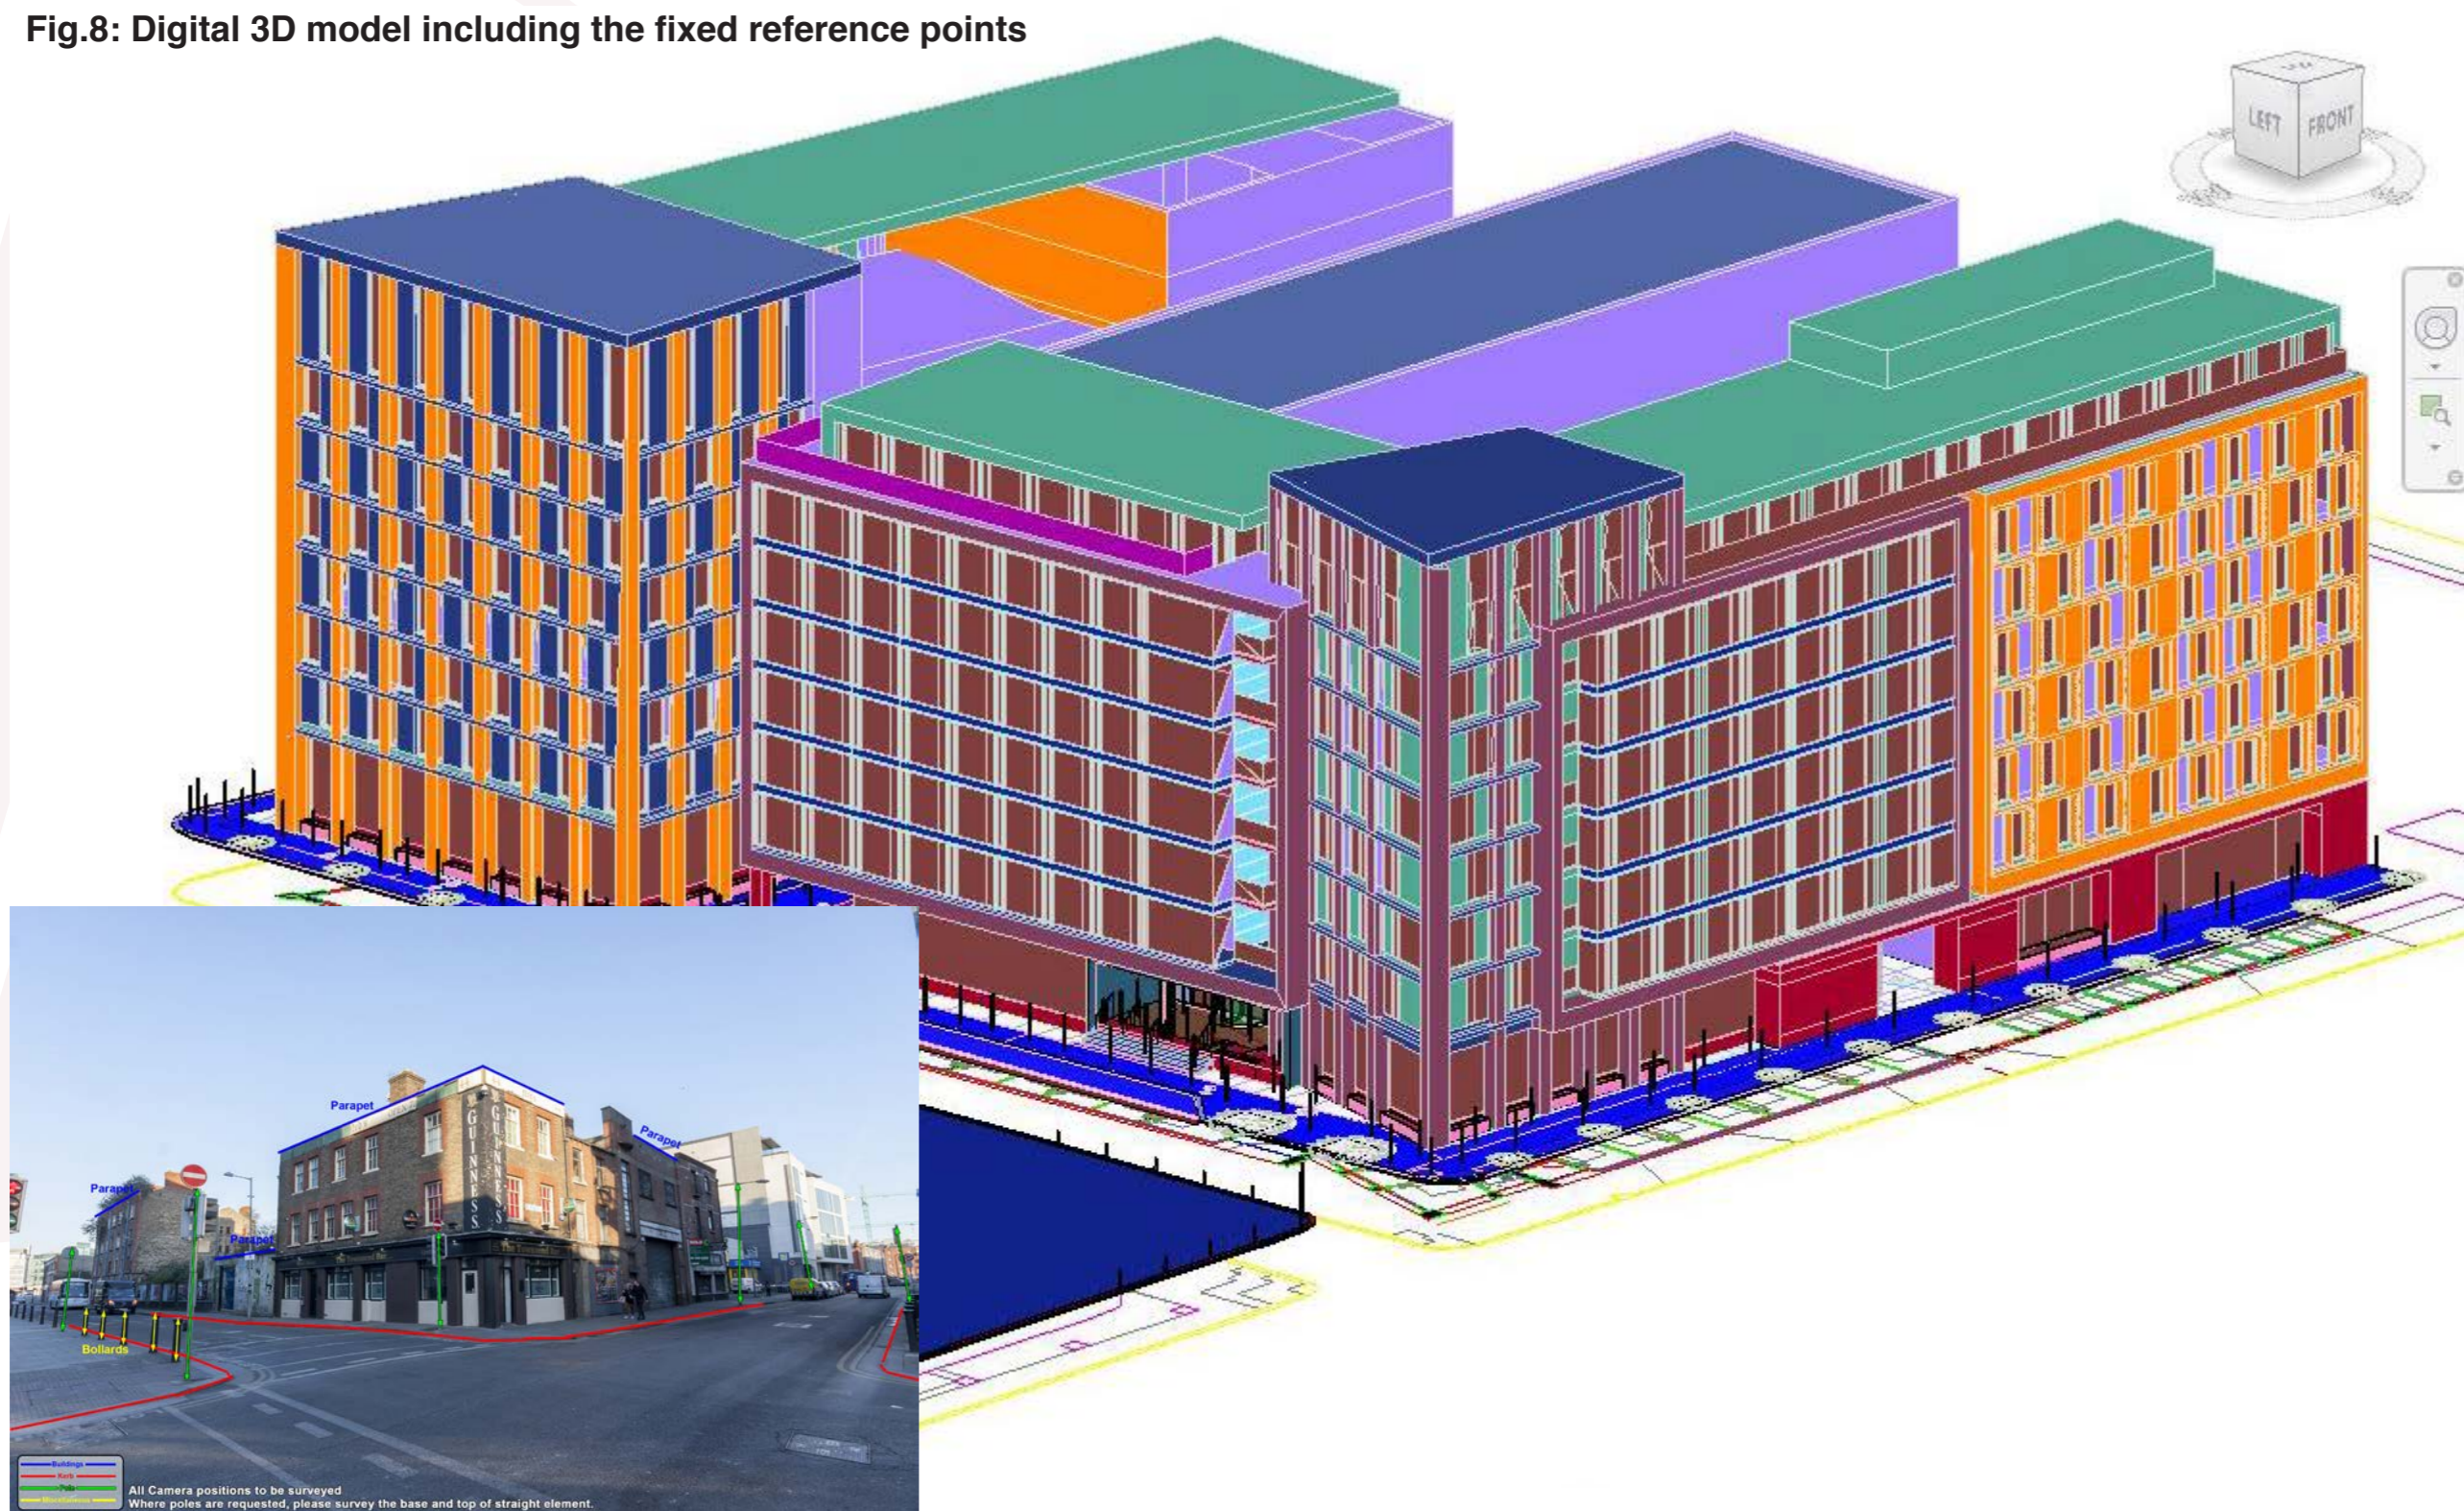
Fig.8: Digital 3D model including the fixed reference points

Fig.9: Fixed reference points surveyed and numbered by surveyor.

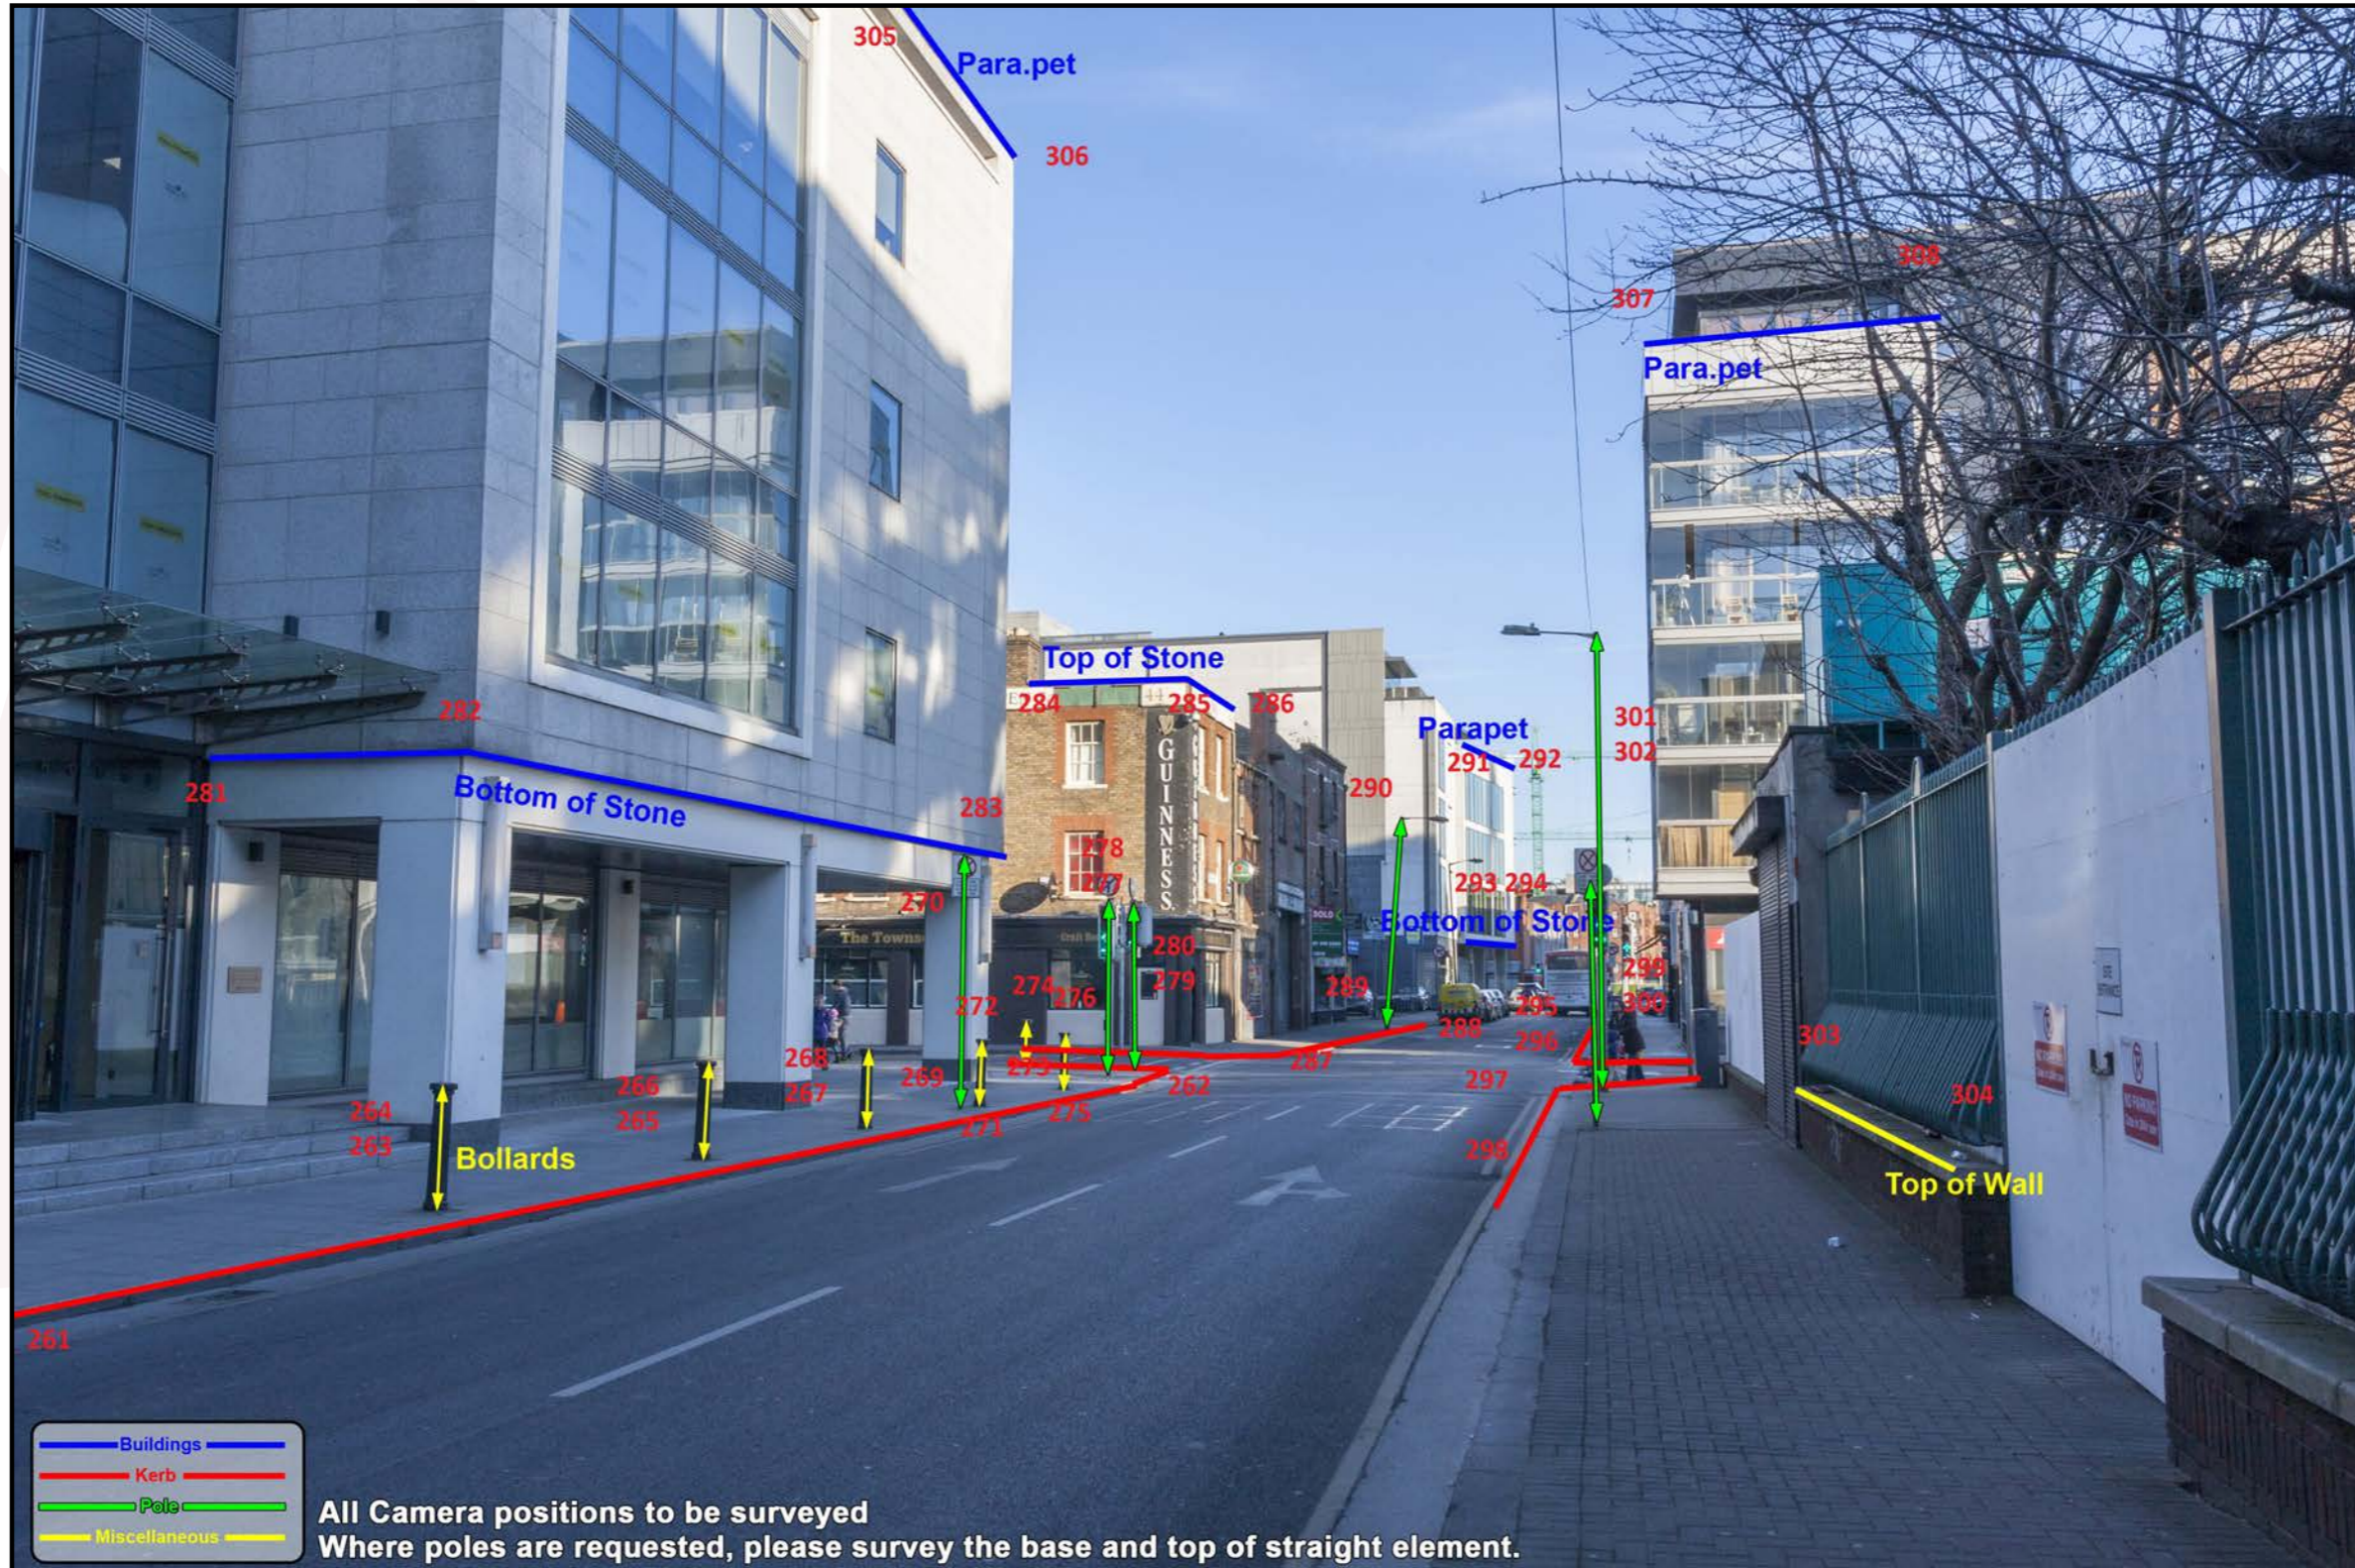
Fig.10: Fixed reference points for surveyor on Baseline untreated photo.
