HOLLYSTOWN KILMARTIN SITE 4

ENVIRONMENTAL IMPACT ASSESSMENT REPORT (EIAR) VOLUME 3 : APPENDICES

6733_RPEIA01_Environmental Impact Assessment Report (EIAR) Volume 3 : Appendices

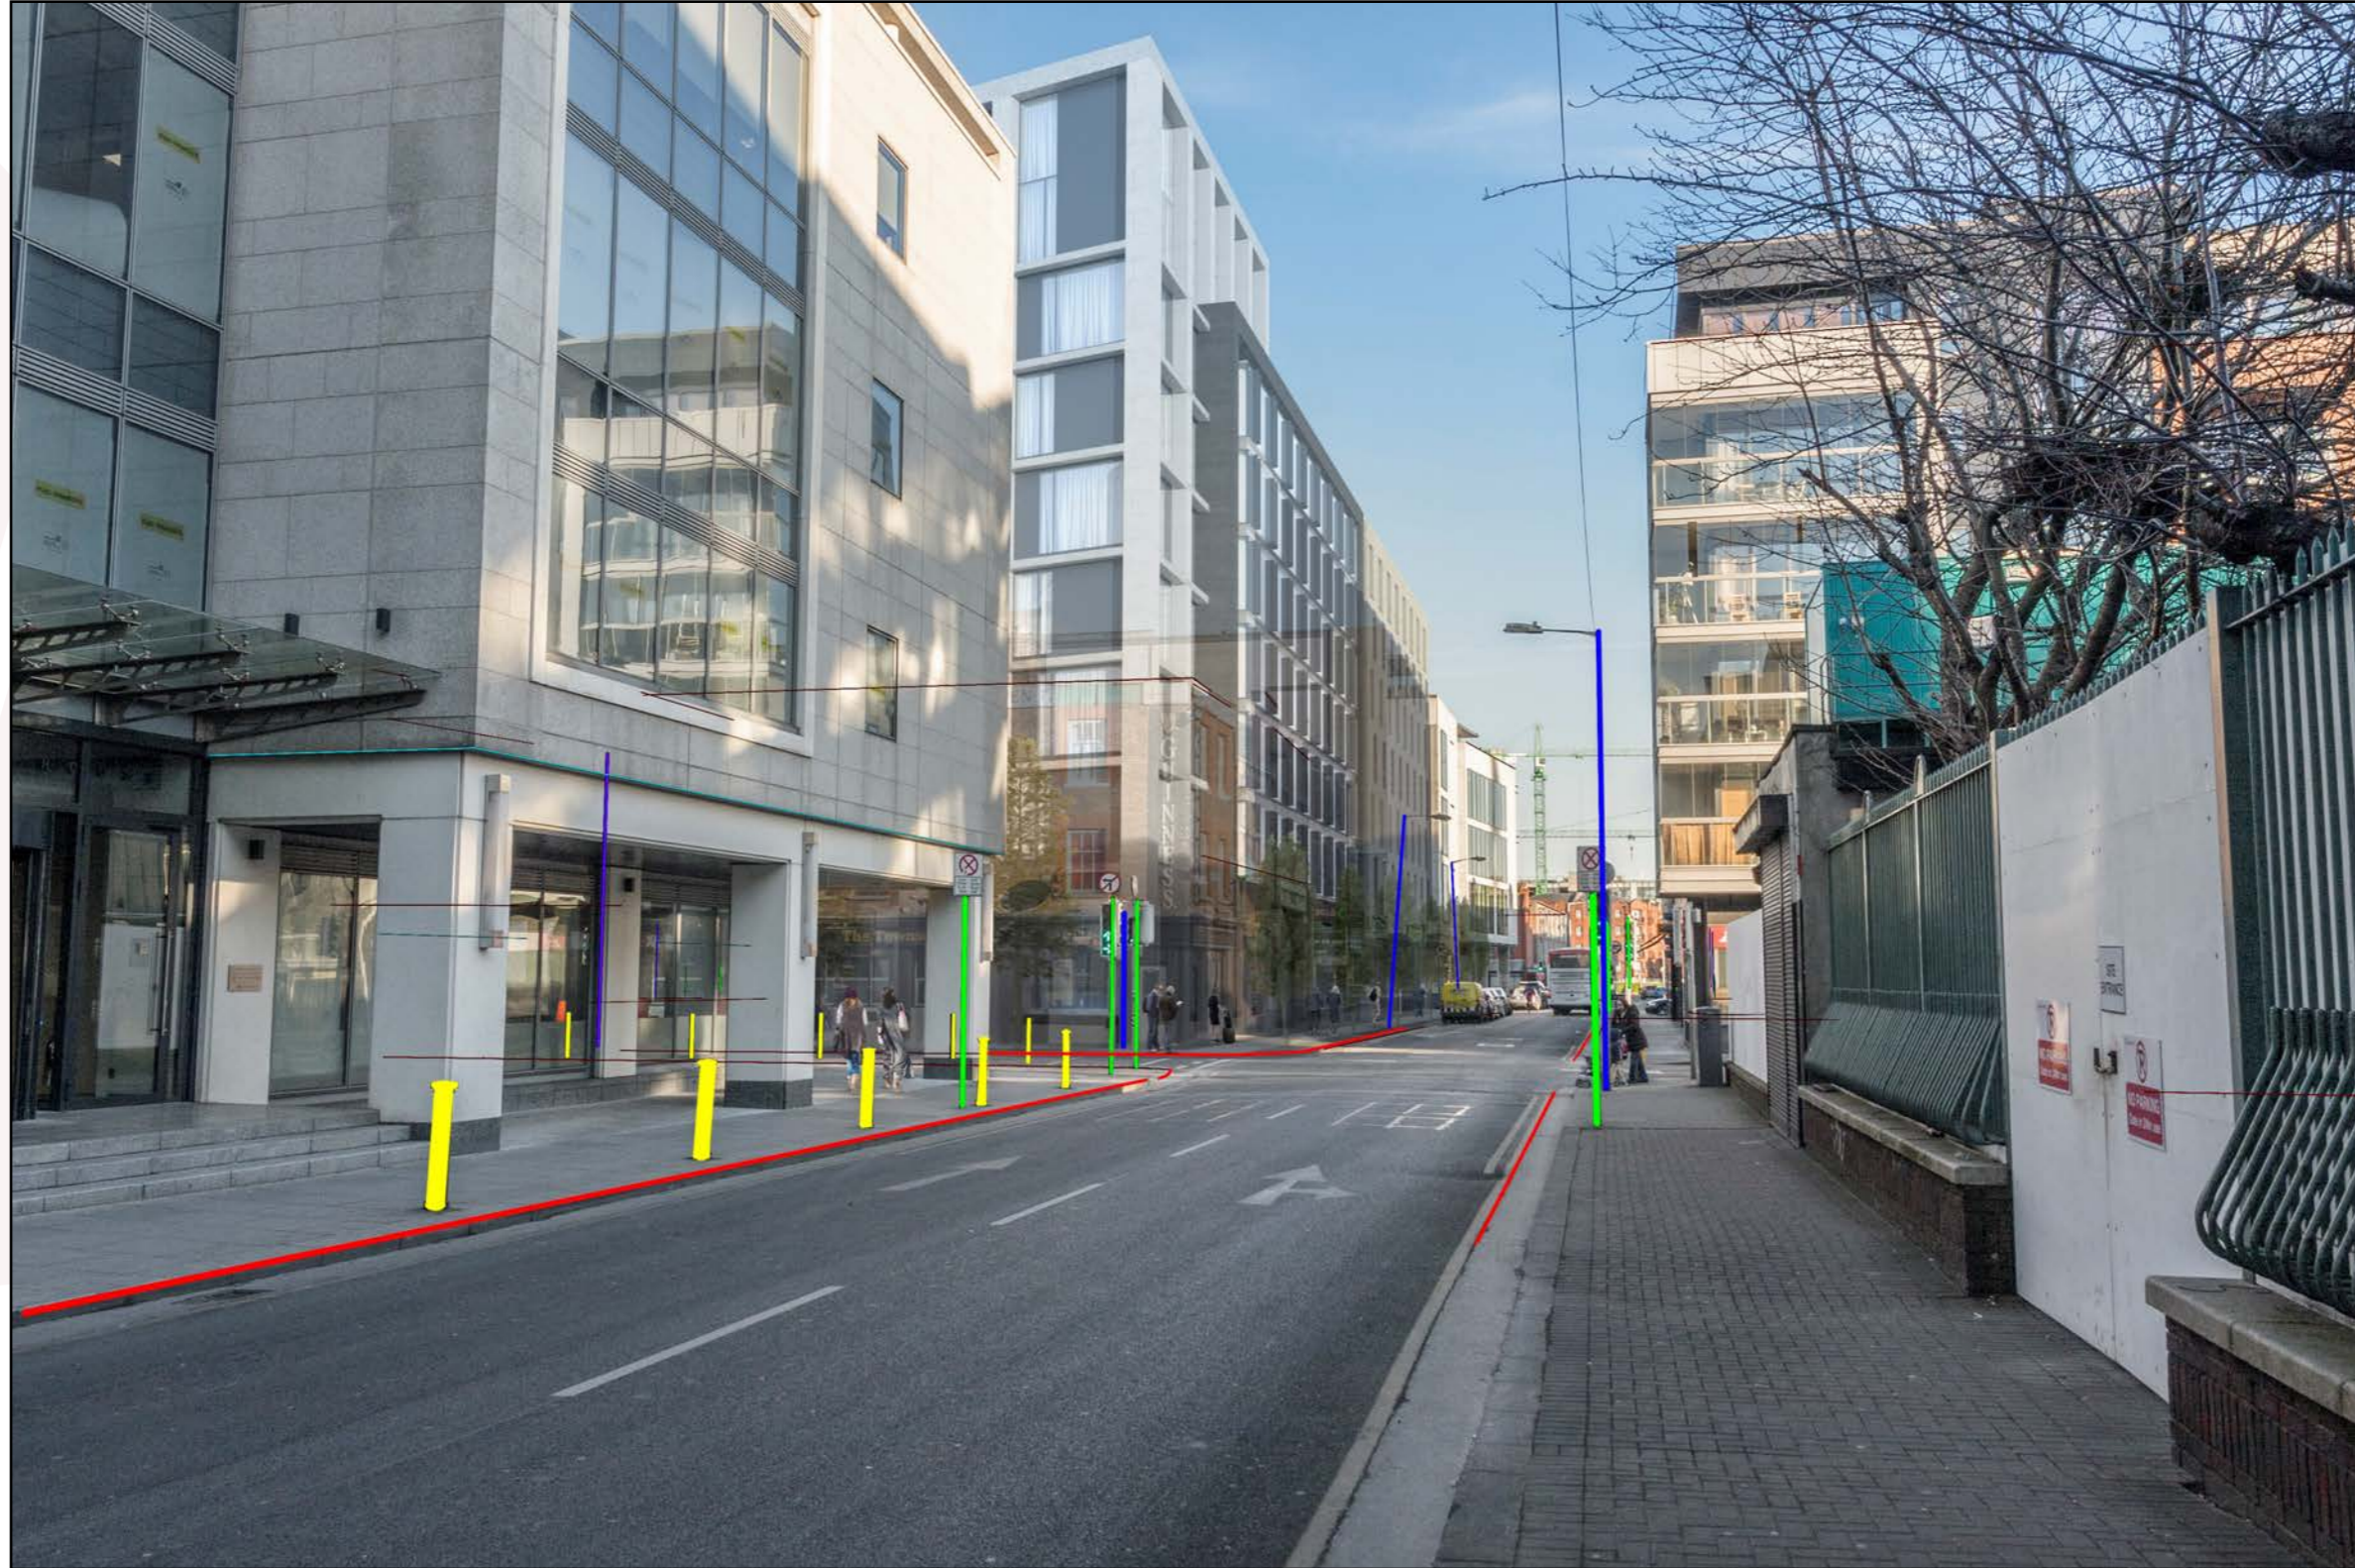
Fig.11: Fixed reference points modelled, rendered and overlaid on baseline photo confirming accuracy

The resulting VVM, having gone through this extensive procedure, is classed as an accurate and verifiable representation of the proposed development as viewed from the selected photo locations. This shows, as closely as possible, any future impact a proposed development may have on the surrounding environment and existing buildings. It should be noted that the foundation of any Landscape/Townscape Visual Impact Assessment (LVIA / TVIA) report are accurate verified view montages.

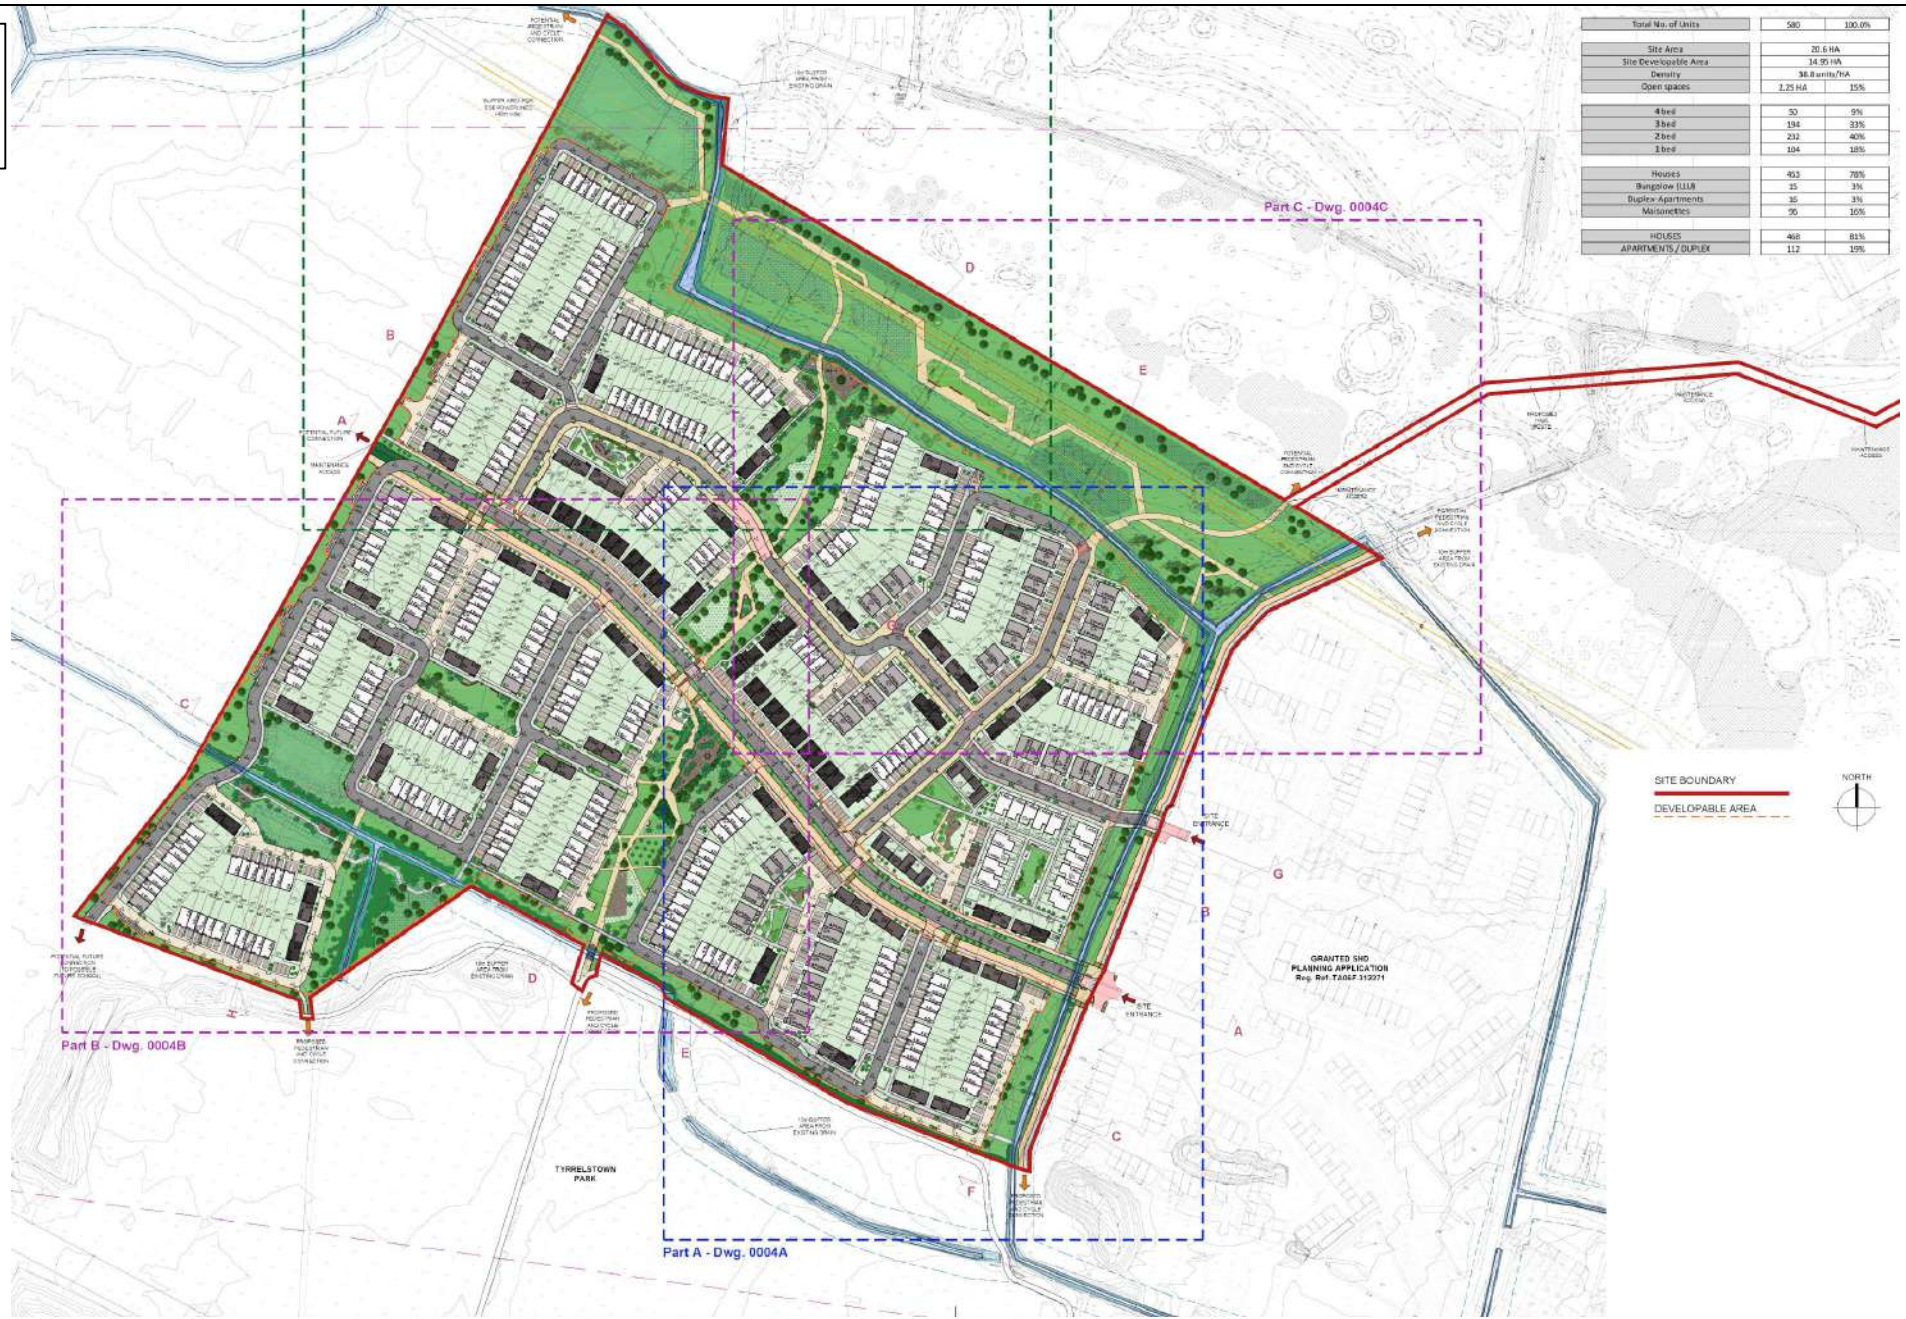
Total No. of Units	580	100.0%
Site Area	20.6 HA	
Site Developable Area	14.95 HA	
Density	38.8 units/HA	
Open spaces	2.25 HA	10%
4 bed	50	9%
3 bed	194	33%
2 bed	232	40%
1 bed	104	18%
Houses	403	70%
Bungalow (LLB)	25	3%
duplex Apartments	35	3%
Maisonettes	90	16%
HOUSES	468	81%
APARTMENTS / DUPLEX	112	19%

Title	Plan of proposed development	Scale	1:4000@A4	Drawn by	RB
Project	Hollystown, Co. Dublin	Date	15.08.23	Checked by	FB
		Job no.	J3649	Fig.	2
				Rev.	3

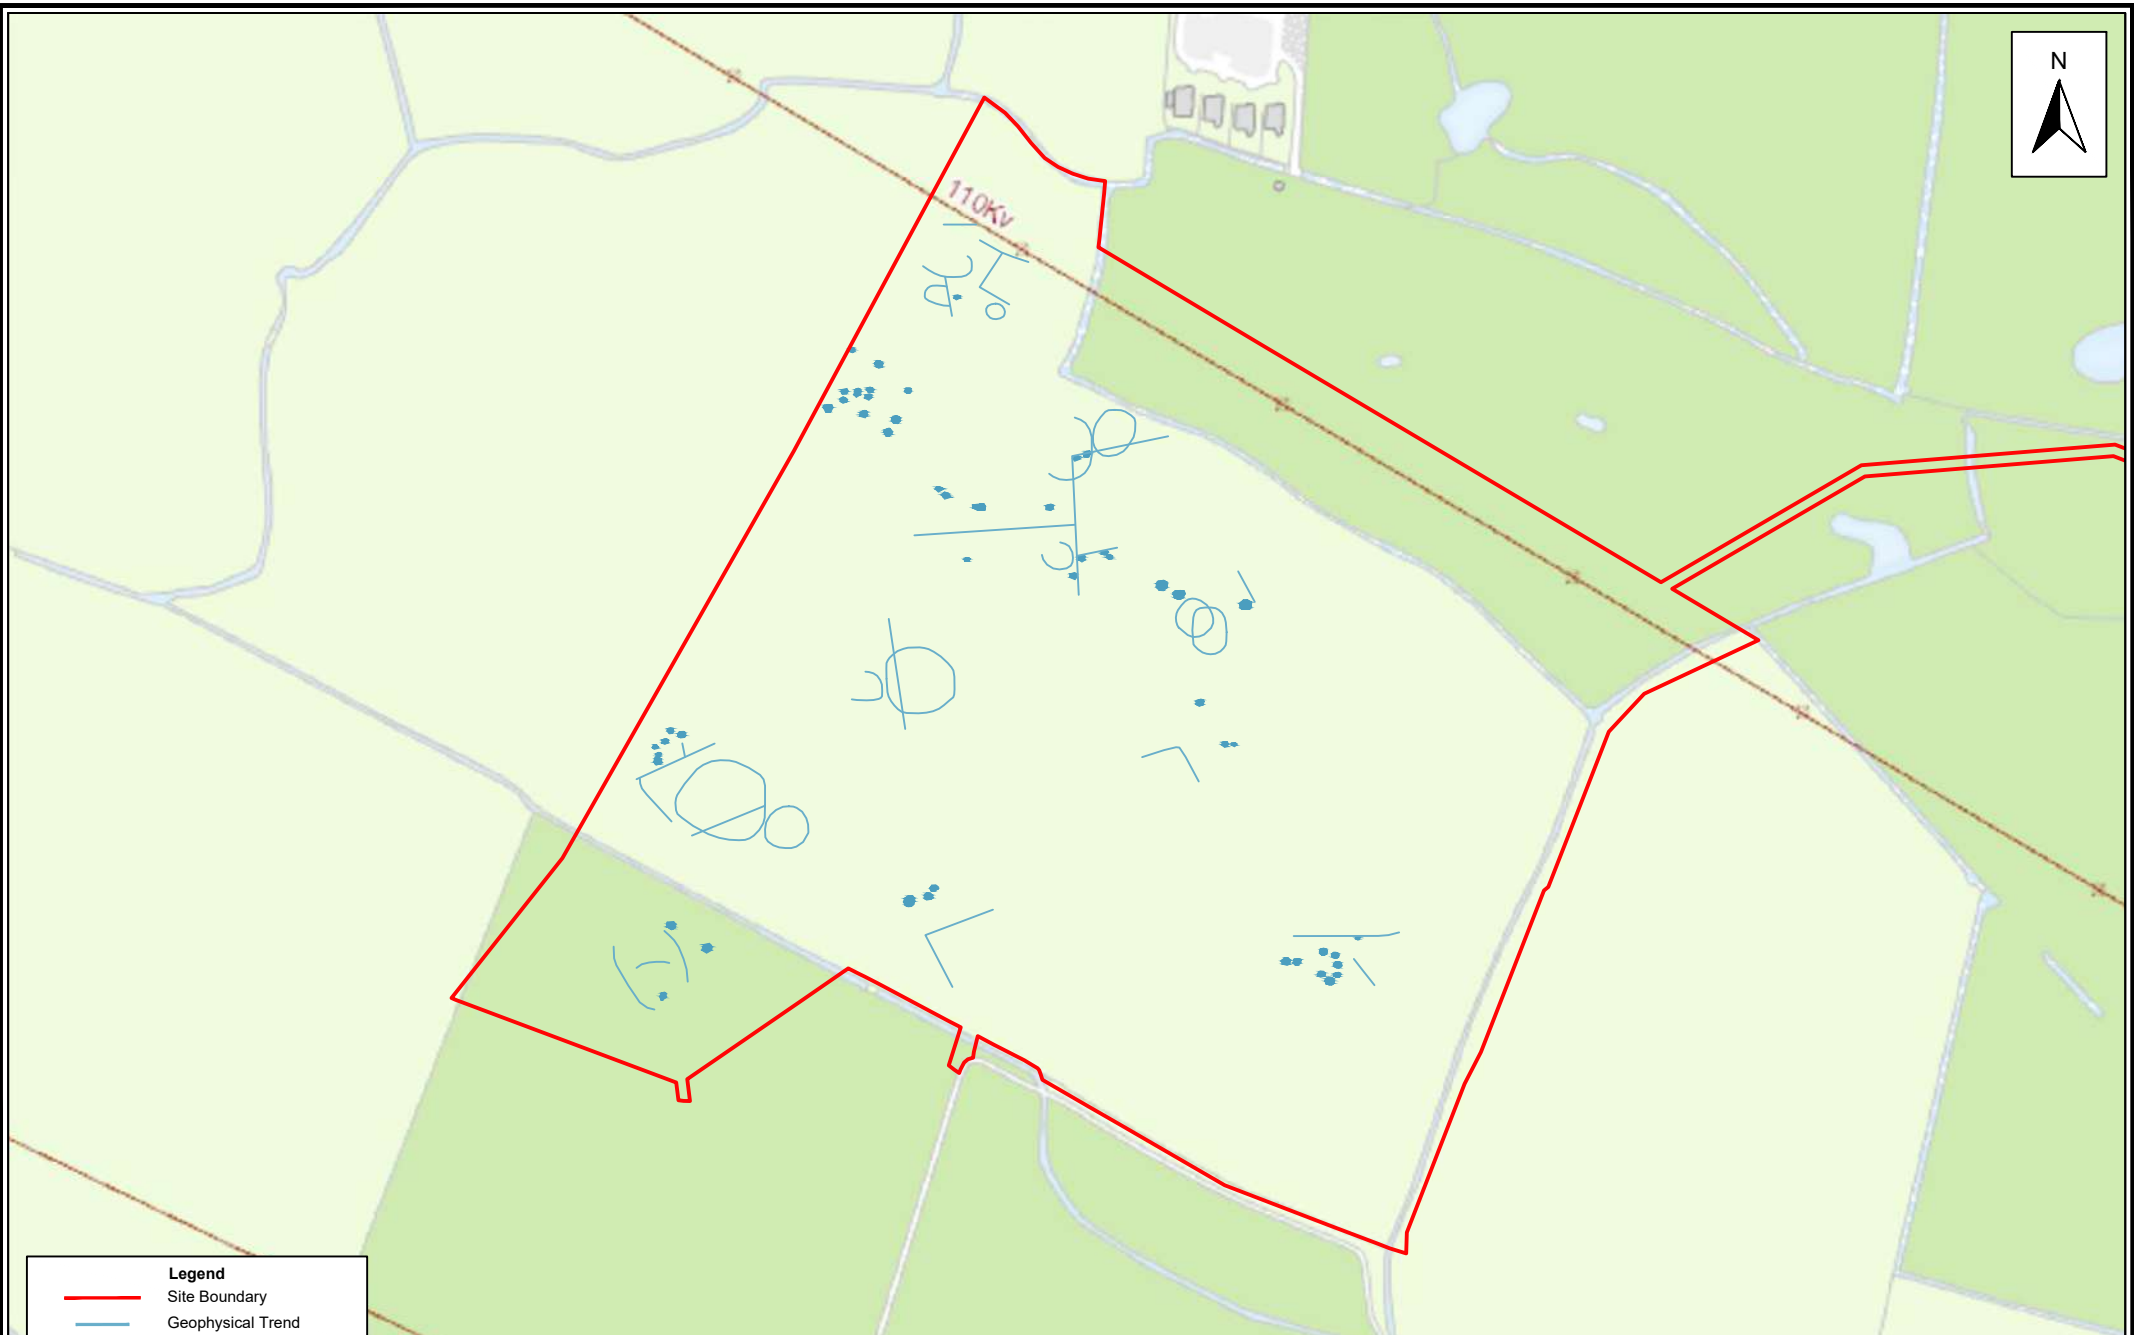
Title	Geophysical survey results overlaying project footprint	Scale	1:4000@A4	Drawn by	RB
Project	Hollystown, Co. Dublin	Date	11.08.23	Checked by	FM
		Job no.	J3649	Fig.	3
				Rev.	2

A geophysical survey was carried out in 2011 across the proposed development area, in order to attempt to locate five monuments identified through aerial photography in the 1980s (Gimson 2011; Licence 11R0152). The survey responses were not strong, but possible pits and two linear trends, possibly representing a relict field division in the field to the south, were identified. Additionally, a series of circular and oval trends indicative of enclosures and a ring-ditch (DU013-032/36-39) were identified in the field to the west, along with possible pits in an oval formation and two possible ditches (Figure 3).

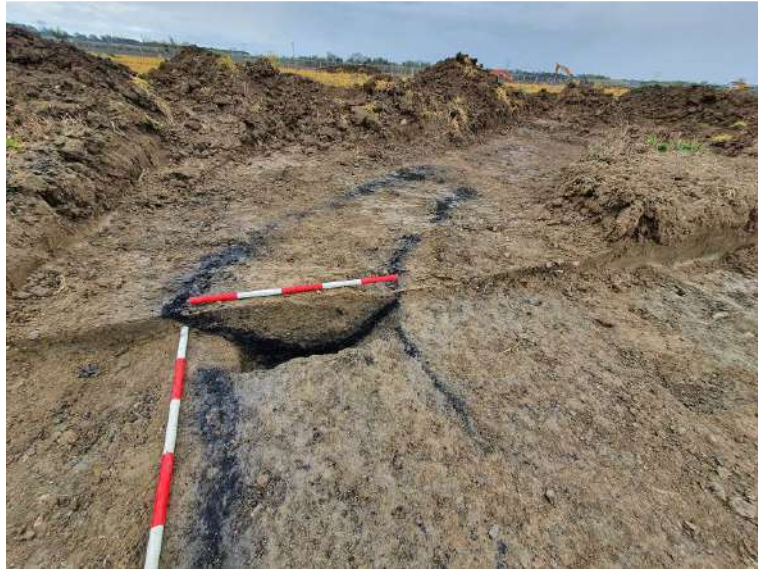
AA1 consisted of a C-shaped linear gully (C18.1) that measured c. 9m in length, 0.91m in width and 0.44m. in depth. The diameter (distance between the two terminals) was c. 7m. The gully had two fills; a charcoal rich lining along the base and sides with a maximum depth of 0.18m (C18.3). The upper fill was a yellowish-brown sandy clay measuring 0.26m in depth (C18.2) (Figure 7; Plate 5). There was some evidence of possible *in-situ* burning at the western end of the gully. The dense charcoal deposit and the *in situ* burning may indicate that the gully represents the remnants of a kiln flue, although no defined kiln furnace or bowl was evident.

Plate 5 C-shaped possible kiln in Trench 18, facing west

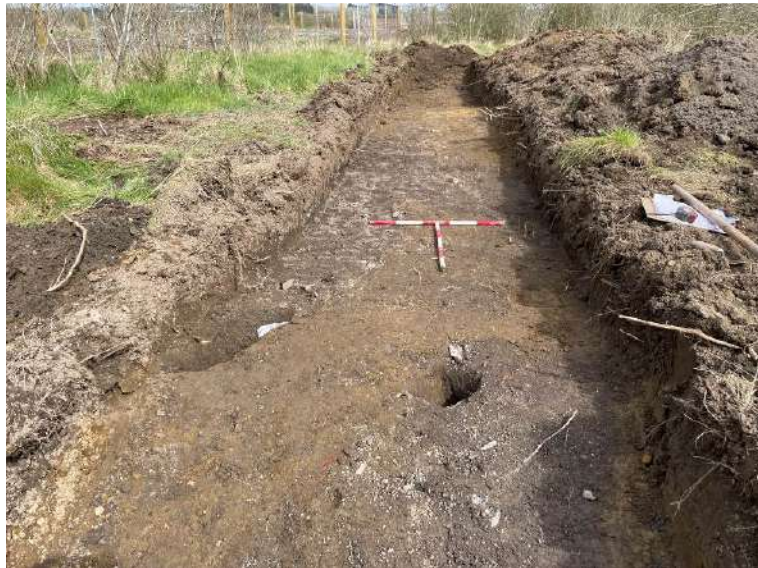
Extensions to Trench 40 revealed a cluster of features c. 14m to the northwest of the slot trench consisting of five pits, two linear ditches, two archaeological deposits/spreads, and four probable field drains. The average dimensions of the pits were 3m (l) by 1m (w) with an average depth of 0.35m (Plate 7). The linear ditches were 0.86m wide and 0.52m deep (C40.2) and 2.05m wide and 0.25m deep (C40.14).

Plate 7 Northern extension of Trench 40, facing north

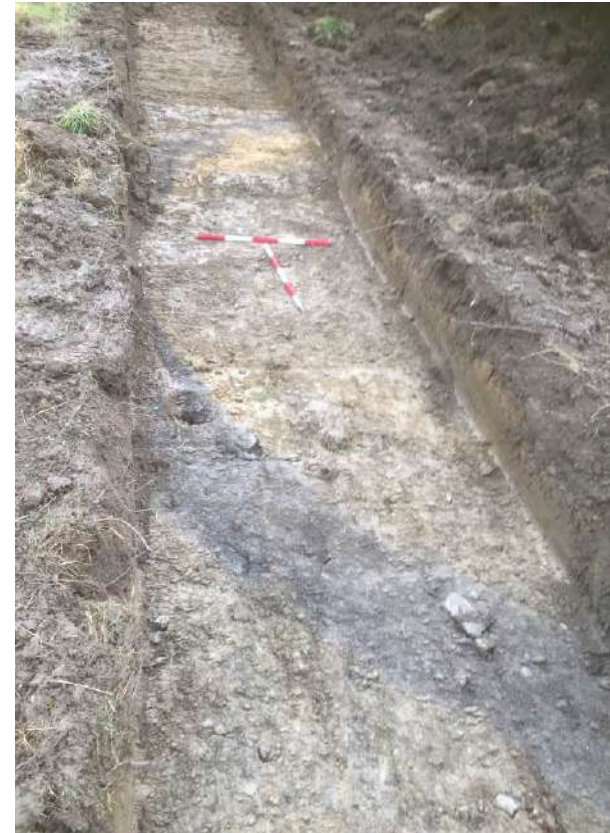
AA2 consisted of a C-shaped or curvilinear slot trench (C40.1) that was 7m in diameter. The slot trench was 0.52m wide and 0.5m deep (Figure 7; Plate 6).

Plate 6 Curvilinear slot trench C40.1, facing southeast

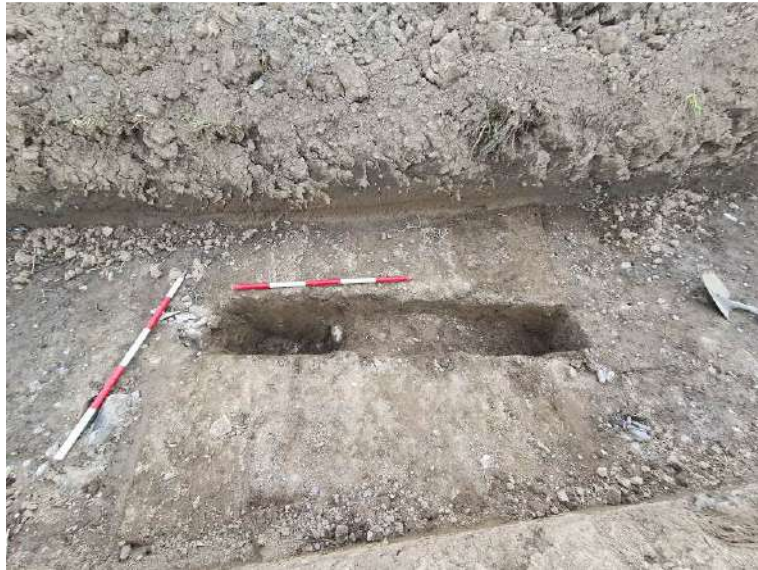
No evidence for RMP DU013-032 was found but the linear feature to the south that was identified by Kavanagh in 2012 was again identified in Trench 4 but not in Trench 3. Kavanagh's trench in 2012 was aligned north–south over the eastern enclosure, whilst Trench 3 and 4 from these testing works were on a similar alignment over the central enclosure, it is unlikely that this forms part of any potential RMP monument and is a drainage channel running east–west through a portion of the site. The southern portion of the geophysical anomaly targeted in Trench 3 were field drains (Figure 8; Plates 8–9).

Plate 8 Drainage channel within Trench 4, facing east

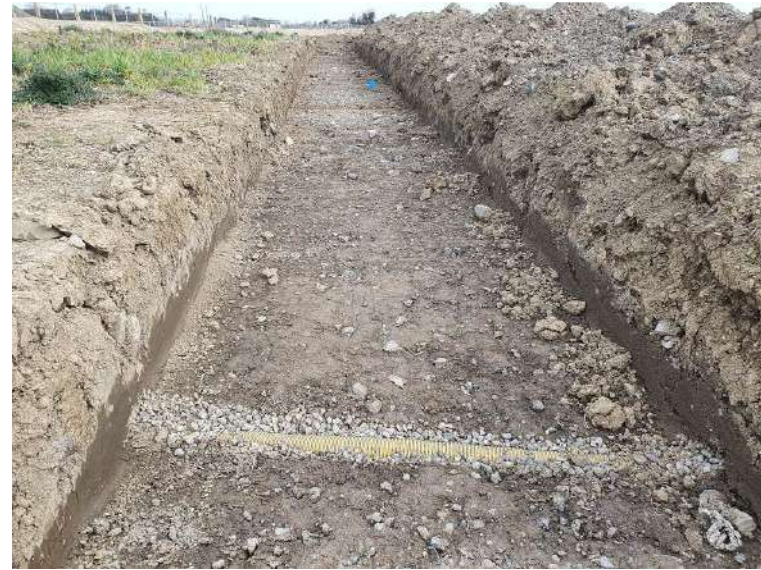
Plate 9 Field drain aligned with geophysics anomaly, Trench 3, facing north

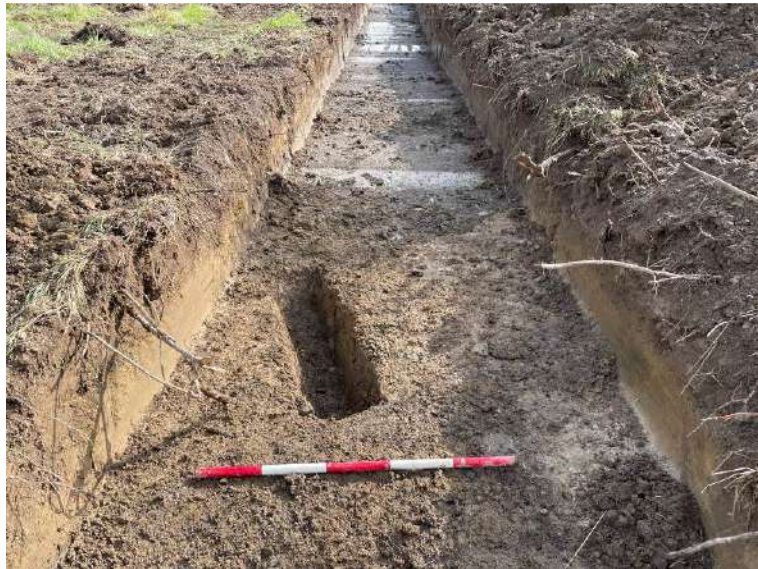
The outer curvilinear anomalies noted from the geophysical survey for DU013-036 did not have any corresponding features within this phase of testing. The inner curvilinear anomaly did correspond with another large drainage channel running east–west that was identified in two Trenches 38 and 41. The aspect identified in Trench 38 is perfectly aligned with the geophysical anomaly but the portion in Trench 41, whilst in direct alignment with Trench 38, was not aligned with the geophysical anomaly (Figure 8; Plate 10–11).

Plate 10 Drainage channel aligned with geophysics Trench 38, facing north

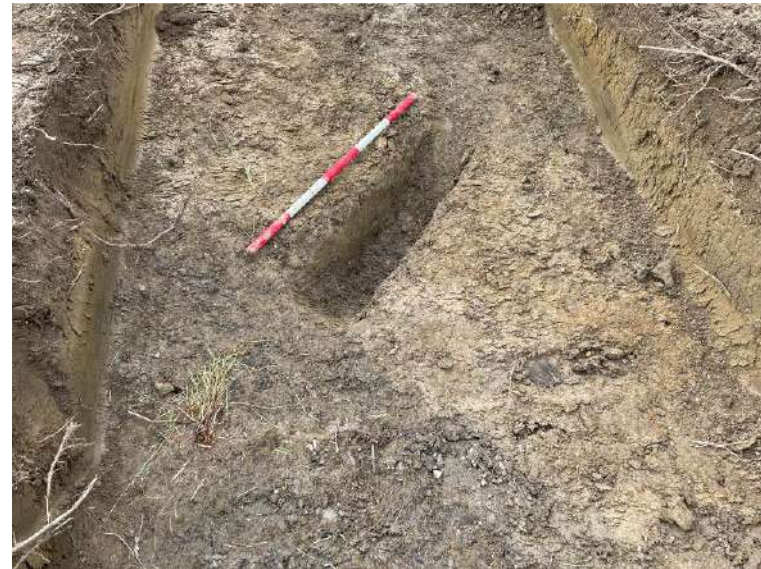
Plate 11 Drainage channel aligned with geophysics Trench 41, facing west

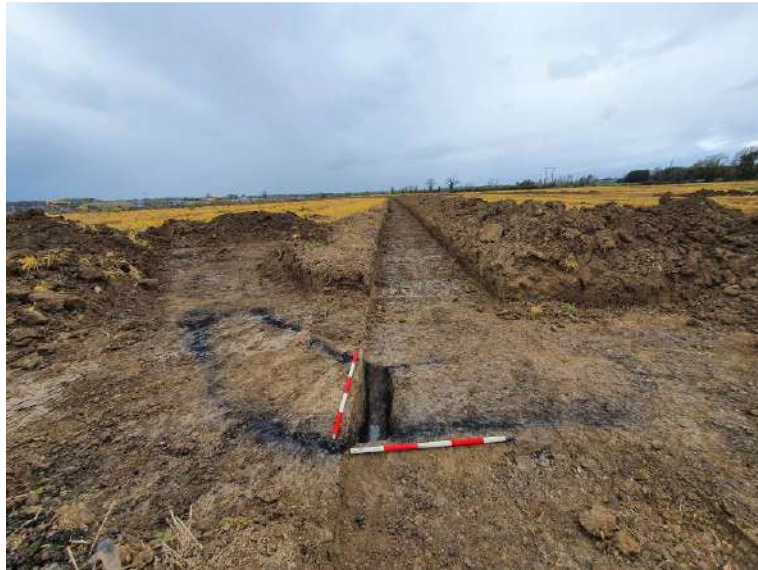
Plate 15 C18.1, Trench 18, facing west

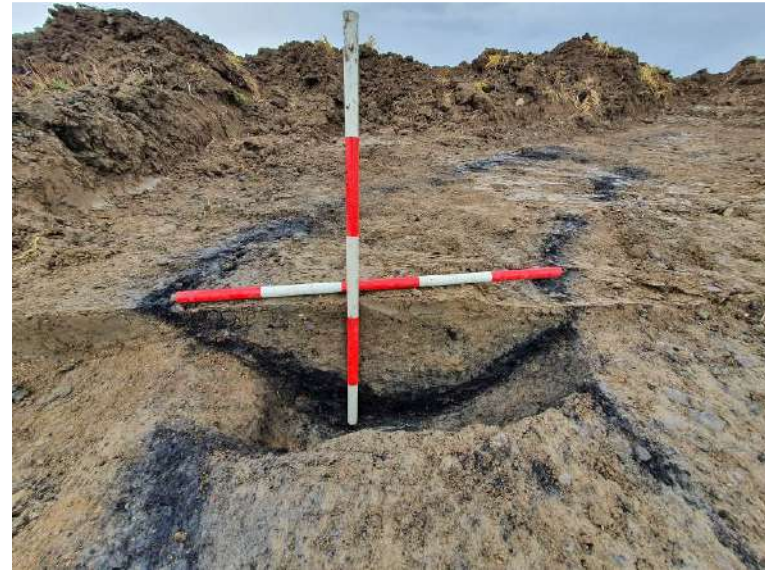
Plate 16 C18.2-3, facing south

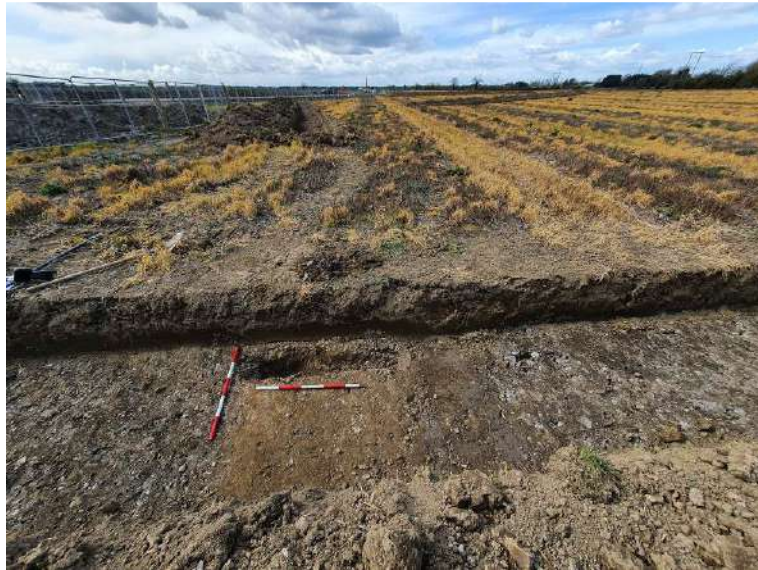
Plate 18 C21.1, facing southeast

19	80	2	0.6	Northwest-southeast	No Archaeology found. A linear trend and possible circular enclosures were targeted from the geophysics (DU013-037).
20	80	2	0.5	Northwest-southeast	No Archaeology found. No geophysical anomalies targeted.
21	50	2	0.28	Northwest-southeast	A possible drainage channel C21.1 was recorded here in line with the targeted geophysics anomaly (DU013-039). C21.1 is curvilinear in plan with a sharp break of slope at top steep side at the east the base appeared to be flat but the water table was present here also. It measures c.2m in width and 0.64m deep. C21.1 is filled by C21.3 and C21.2 . The basal fill, C21.3 is a firmly compacted light grey clay with occasional orange mottling and small stone inclusions, rare charcoal flecks were also notes at 0.25m depth. This is c.2m in width and 0.4m deep. The upper fill C21.2 , is a loosely compacted mottled orange/grey silty clay with occasional small stones. Plate 18

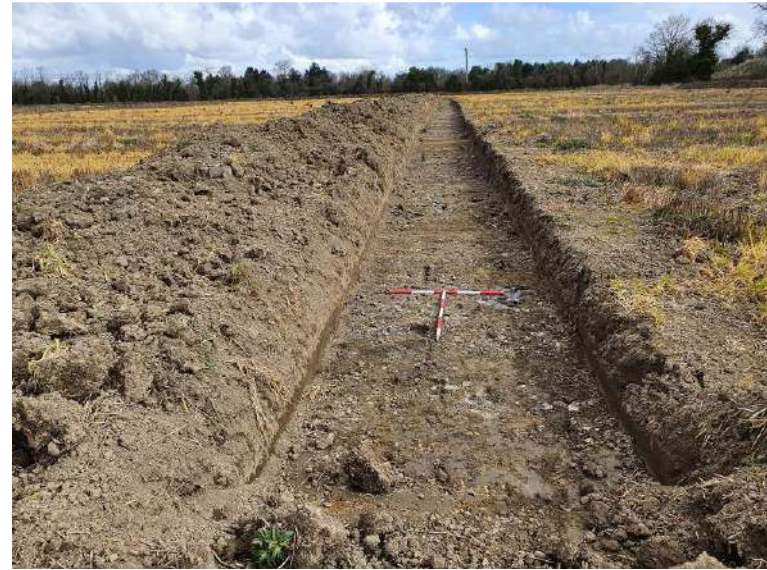
Plate 19 C22.1, facing west

22	32	2	0.55	North-northeast-south-southwest	An east–west running drainage channel C22.1 was noted in this trench. This drainage channel is in alignment with the C21.1 the drainage channel noted in Trench 21. A linear trend was targeted from the geophysics (Du013-039) Plate 19
23	60	2	0.5	Northwest-southeast	No Archaeology found. No geophysical anomalies targeted.

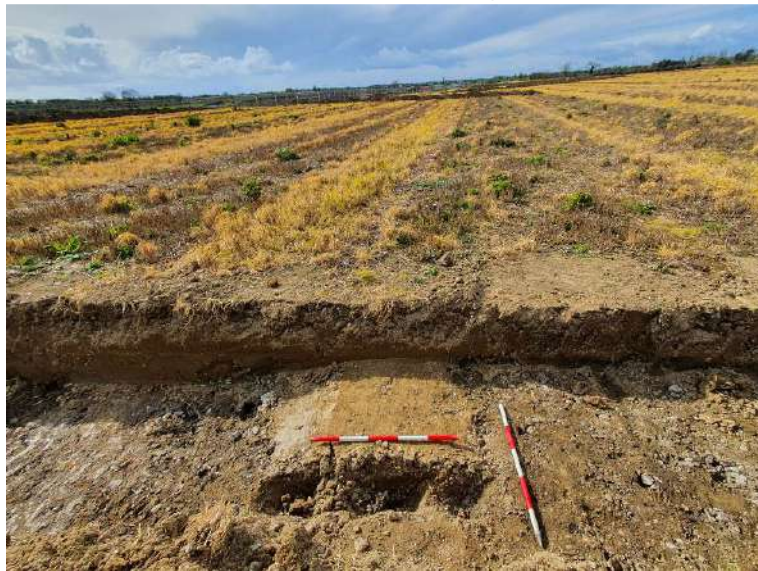
Plate 20 Trench 27, facing north

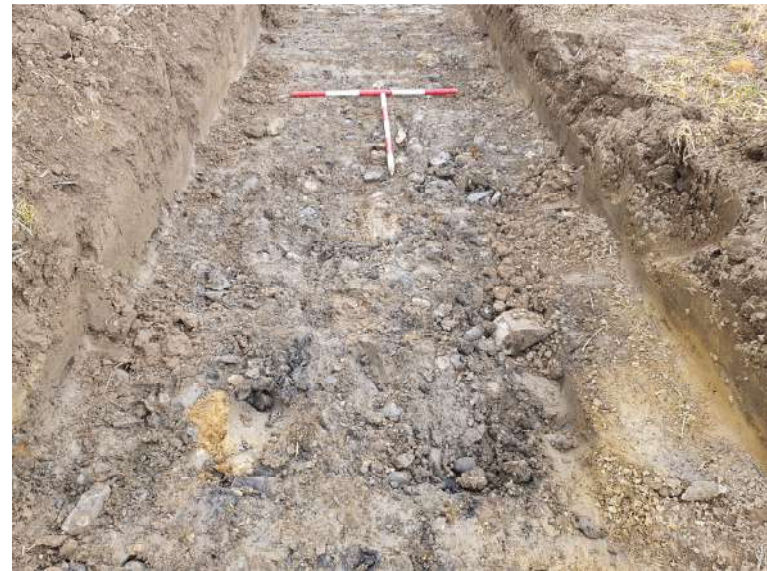
Plate 21 C29.1, facing west

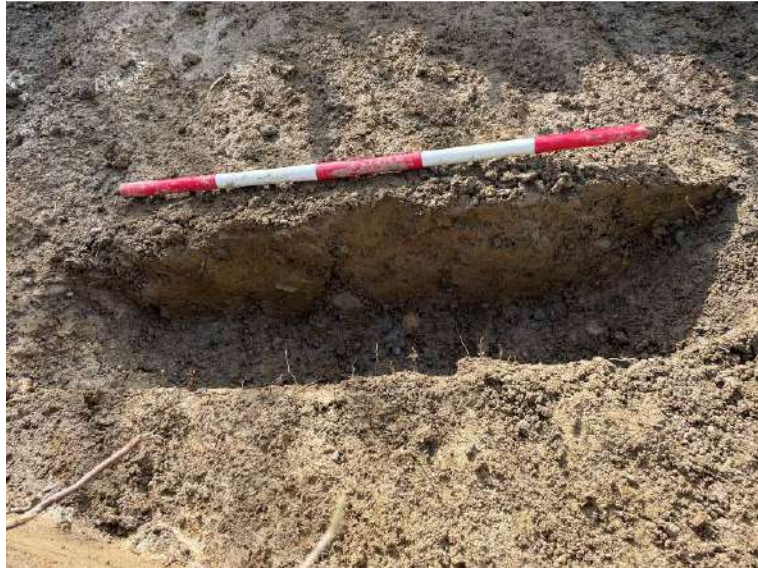
Plate 22 Geology change in Trench 37, facing west

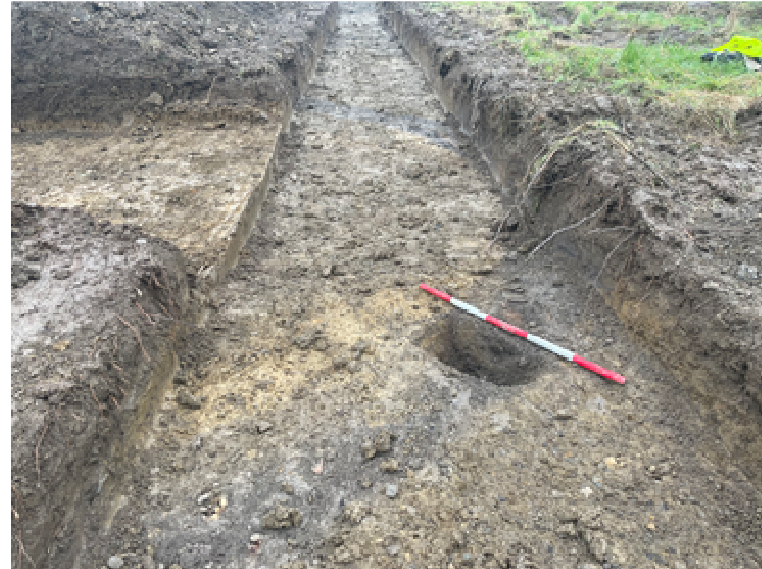
Plate 23 C38.1, facing southwest

32	31	2	0.48	Northeast–southwest	No Archaeology found but an old field boundary running northwest–southeast was identified. No geophysical anomalies targeted.
33	38	2	0.54	Northeast–southwest	No Archaeology found. No geophysical anomalies targeted.
34	34	2	0.48–0.62	North-northwest–south-southeast	No Archaeology found. No geophysical anomalies targeted.
35	51	2	0.41–0.65	Northwest–southeast	No Archaeology found. No geophysical anomalies targeted.
36	40	2	0.5	North–south	No Archaeology found. A cluster of circular anomalies were targeted at the southern end of the trench and an east–west running linear trend.
37	40	2	0.38	West–east	No Archaeology found. A cluster of circular anomalies were targeted at the western end of the trench and a northwest–southeast running linear trend which aligned with a slight change in the geology with a greater amount of decayed stone present here. Plate 22
38	46	2	0.6	Northeast–southwest	A possible drainage channel C38.1 aligned with a curvilinear trend targeted from geophysics. C38.1 is 1.3m wide and 0.27m deep, it has a sharp break of slope at top gradually sloping sides and a gradual break of slope at base. The base is relatively flat. It is filled by a pale brown clay (C38.2) with some snail shells at the base. C38.1 is in alignment with C41.1 and is likely the same feature. A second curvilinear trend was also targeted in this trench (DU013-036). Plate 23

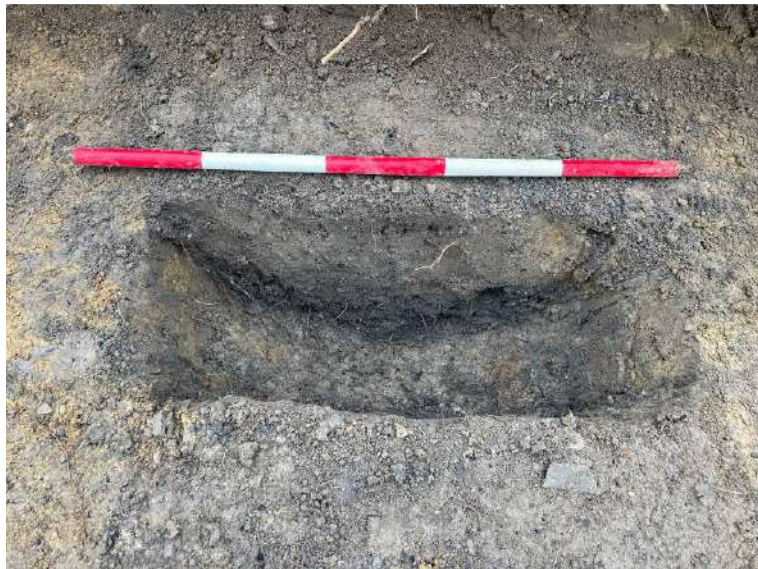
Plate 24 C40.1, facing west

TRENCH	LENGTH (m)	WIDTH (m)	DEPTH (m)	ORIENTATION	DETAILS
				southeast	targeted at the western end of the trench.
40	50	2	0.5–0.6	East–west	<p>A C-shaped curvilinear slot C40.1 was identified in the middle of the trench (Plate 6). It has a sharp break of slope at the top steep near vertical sides and a gradual break of slope leading to a concave base. The internal diameter of this slot is 7m whilst the slot itself is 0.52m wide and 0.5m deep. C40.1 is filled mid–dark grey clay with frequent charcoal and occasional animal bone present (C40.15). The trench was extended to the south to try and locate a return for the curvilinear and whilst features were found (C40.2 and C40.3) it is unlikely these represent a return of C40.1 (Plate 24).</p> <p>C40.2 is a linear ditch feature running east–west located south of C40.1 and has two fills. It measures 0.86m wide and 0.52m deep. The basal fill, C40.16, which also lines the sides, is composed of a soft dark charcoal rich clay with frequent animal bone. The upper fill, C40.17, is composed of a friable, mid-grey clay with frequent charcoal and animal bone (Plate 25).</p> <p>C40.3 is a linear drain roughly parallel to C40.2 located 0.1m further south. It measures 0.38m wide and 0.2m deep. The fill, C40.18, is composed of a firmly compacted, light greyish brown clay with flecks of charcoal and animal bone.</p> <p>C40.4 is a field drain running north–south and is filled (C40.19) with a soft dark grey clay with some animal bone present. It is 0.45m wide.</p> <p>C40.5 is a linear gully or drain measuring 0.7m wide and 0.35m deep. It has a sharp break of slope at top steep sides and a gradual break of slope at the relatively flat base. It is filled (C40.20) with a soft dark grey clay with occasional flecks of charcoal and frequent animal bone (Plate 26).</p> <p>C40.6 is a field drain running north–south and is filled (C40.21) with a soft dark grey clay with some animal bone present. It is 0.45m wide and 0.3m deep, very similar to C40.4.</p> <p>C40.7 is a sub rectangular pit with a sharp break of slope at top steep sides and a gradual break of slope at a concave base. It measures 3.1m long x 1.2m (exposed) wide and 0.35m deep. It has two fills, the basal fill, C40.22, consists of a very loose, dark grey clay with charcoal with rare flecks of burnt bone. The upper fill, C40.23, consists of a dark grey friable clay with frequent charcoal, animal bone and occasional medium sized stones with average diameter 0.1m (Plate 27).</p> <p>C40.8 is a large oblong pit with a sharp break of slope at the top, steep sides and a gradual break of slope at a concave base. It measures 3.4m long x 0.7m (exposed) wide and 0.4m deep. It is filled</p>

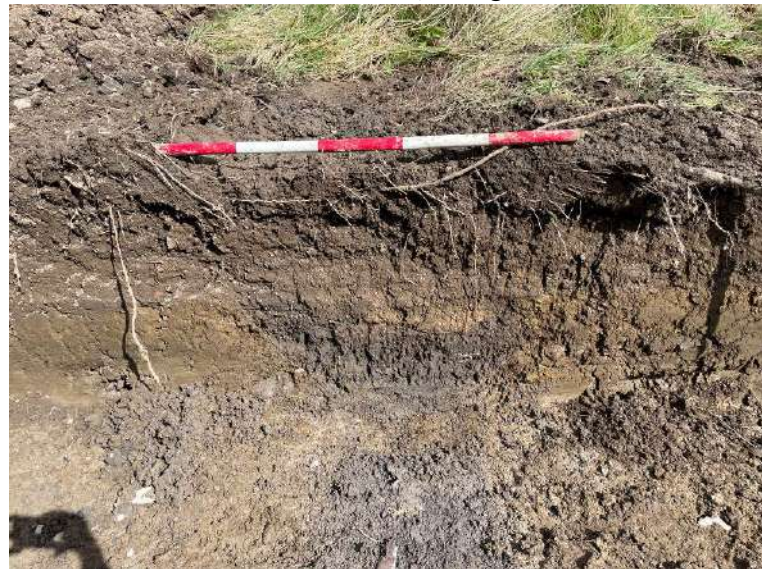
Plate 25 C40.2, facing east

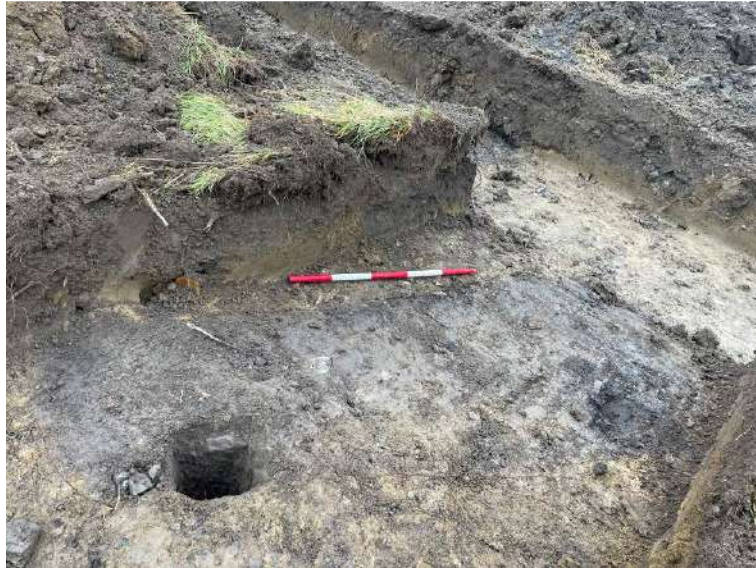
Plate 26 C40.5, facing north

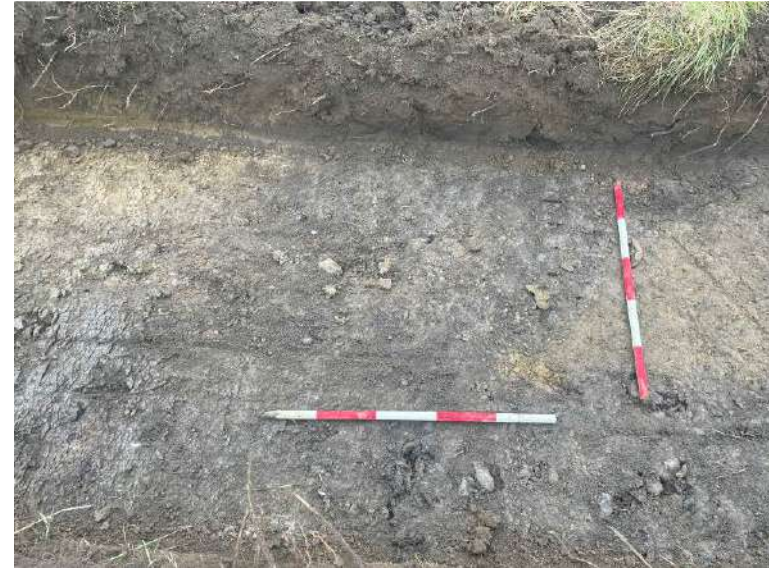
Plate 27 C40.7, facing southeast

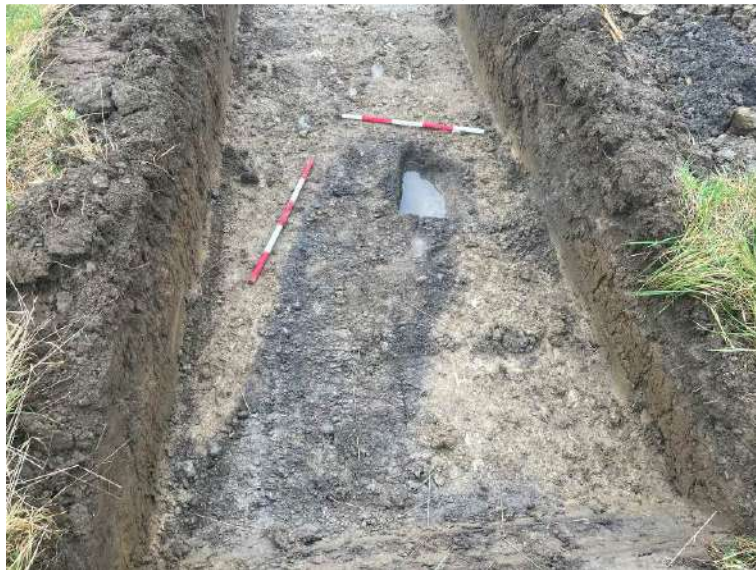
Plate 28 C40.8 and C40.9, facing east

TRENCH	LENGTH (m)	WIDTH (m)	DEPTH (m)	ORIENTATION	DETAILS
					<p>(C40.24) with a dark grey friable clay with frequent charcoal and animal bone. A cluster of charred seeds was also noted at 0.1m depth.</p> <p>C40.9 is another large pit with an uncertain relationship with pit C40.8. The fill (C40.25) of these pits (C40.8 & C40.9) have the same colour and consistency. It measures 3m (exposed) in length and 1.6m in width.</p> <p>C40.10 is a large oblong pit with a sharp break of slope at the top steep sides and a gradual break of slope at a concave base. It measures 2.5m in exposed length, 0.8m in width and 0.2m deep. It is filled (C40.26) by a loosely compacted dark grey clay that is charcoal rich and has animal bone present (Plate 29).</p> <p>C40.11 is a spread of material sub oval in shape and consists of a mid-grey clayey silt with occasional animal bone and flecks of charcoal present. It measures 1m in exposed length, 1.5m wide and 0.1m in depth.</p> <p>C40.12 is an oblong shaped spread of material mid-greyish brown in colour with flecks of charcoal and occasional small stones present. Possible in-situ burning also present at the southern end of the feature. It measures 1.5m in length, 0.5m in width and 0.08m deep. Is an oval shaped pit (Plate 30)</p> <p>C40.13 is an oval shaped pit sub circular in shape with a sharp break of slope at top gradually sloping sides and a gradual break of slope at a concave base. It measures 1.2m in length, 0.9m in width and 0.6m in depth. It is filled (C40.27) by a mid-greyish brown friable clay with occasional flecks of charcoal present.</p> <p>C40.14 is a linear ditch running east–west with a sharp break of slope at top sloping sides and a sharp break of slope at a flat base. It measures 2.05m in width and 0.25m deep. It is filled (C40.28) by a mid-greyish brown silty clay with occasional stone present.</p>

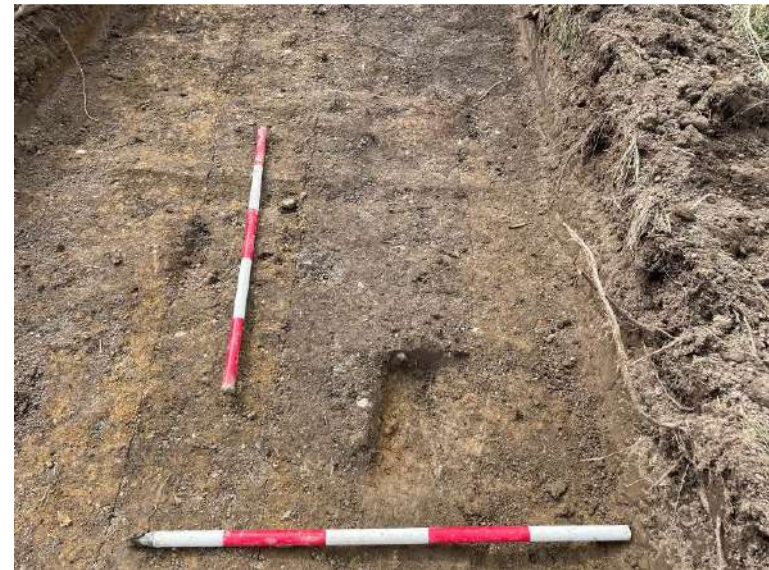
Plate 29 C40.10, facing east
