Site - Specific Flood Risk Assessment

Proposed Residential Development

**Lands in the townlands of Commons West, Boycetown and Kilcock
(adjacent to the existing Brayton Park estate), Kilcock, Co. Kildare**

Rycroft Homes Ltd. (C/O) Pinnacle Consulting Engineers Ltd.	Document Ref. No. 19037-FRA Issue PL2	Kilgallen & Partners Consulting Engineers Well Road, Portlaoise Co. Laois
--	--	--

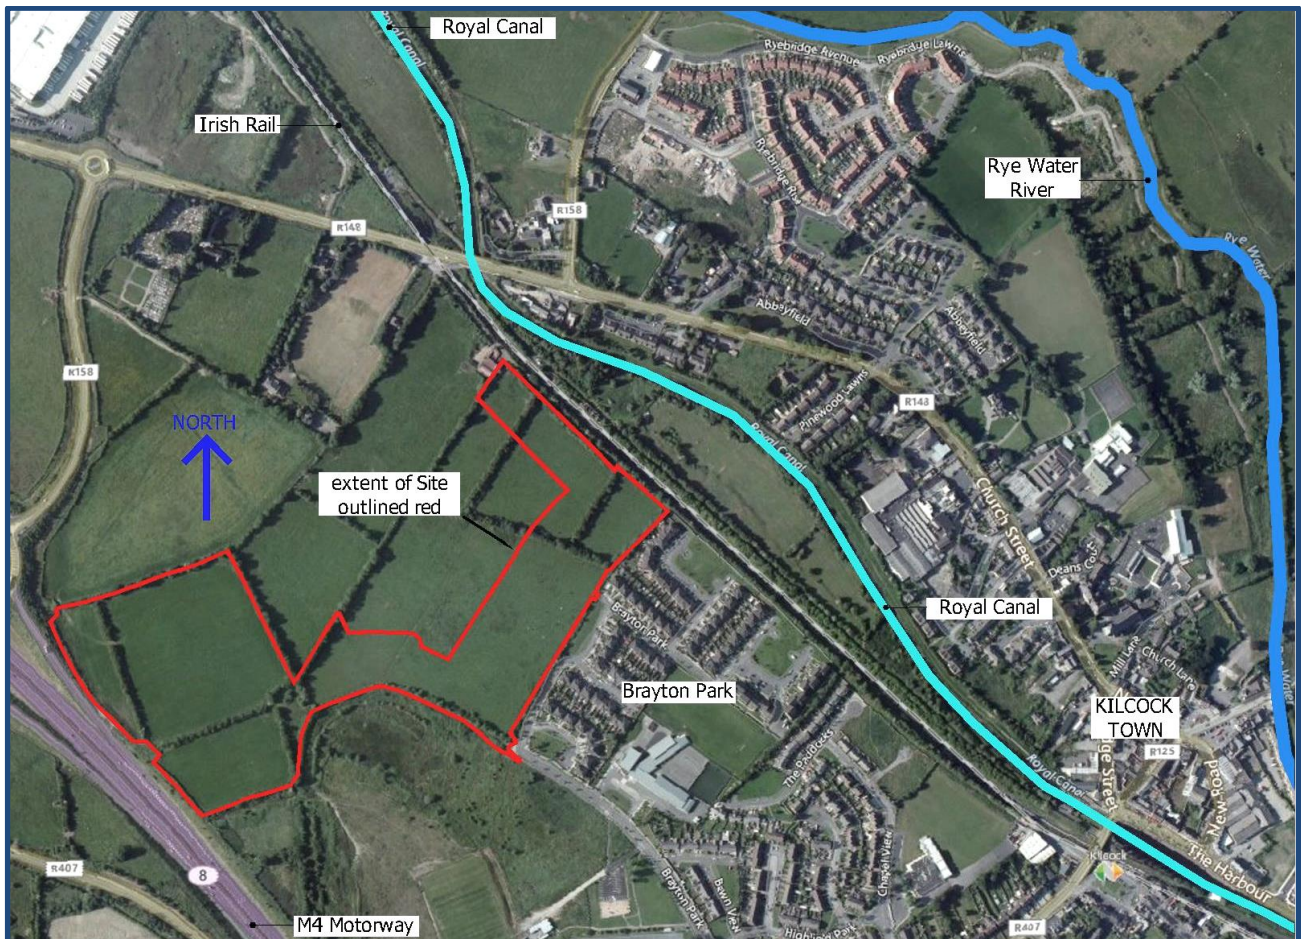
Figure 1.1 – Extent of Site

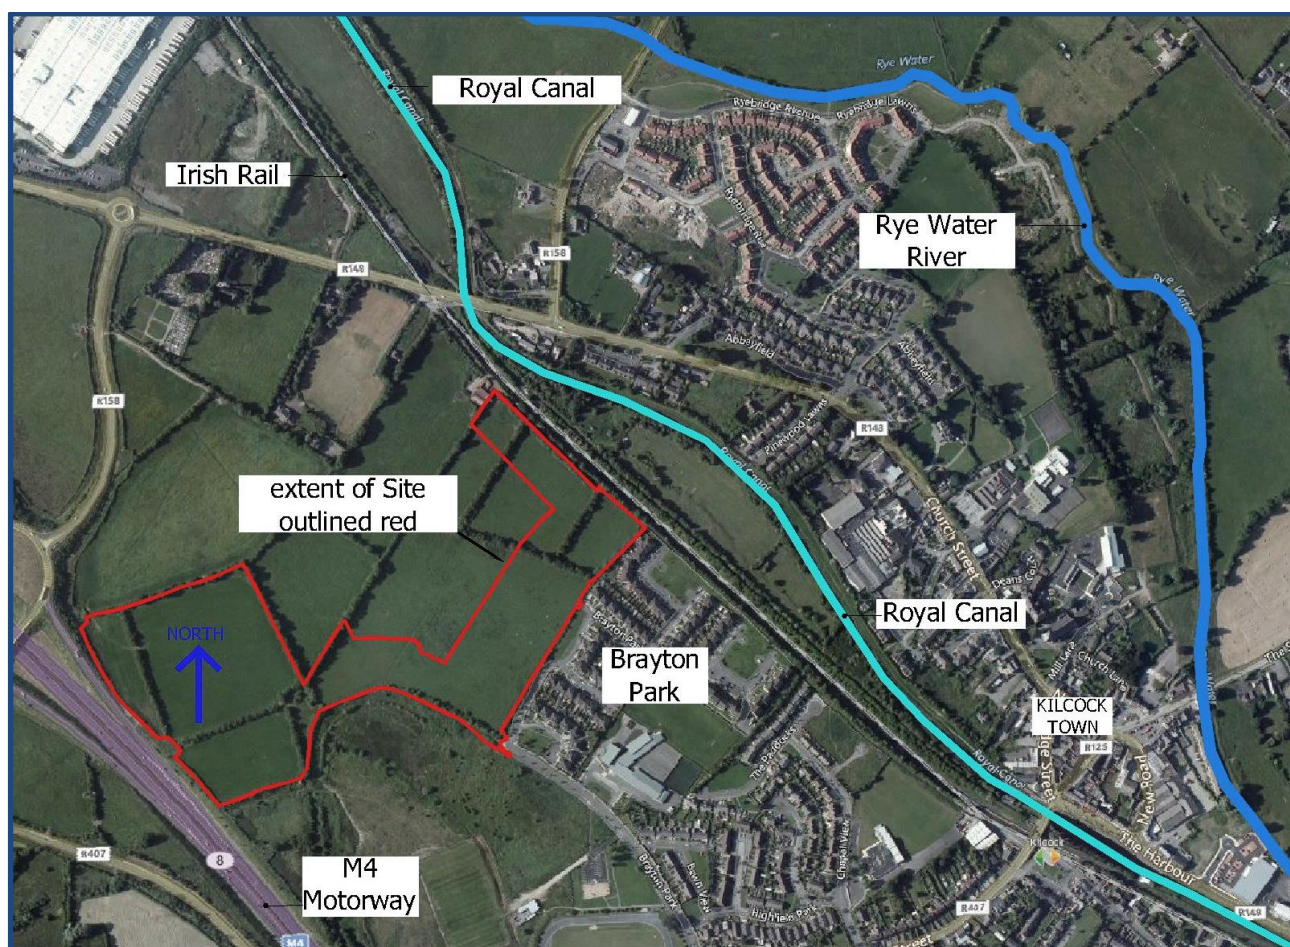
Figure 3-1 Study Area in the Context of Surrounding Rivers

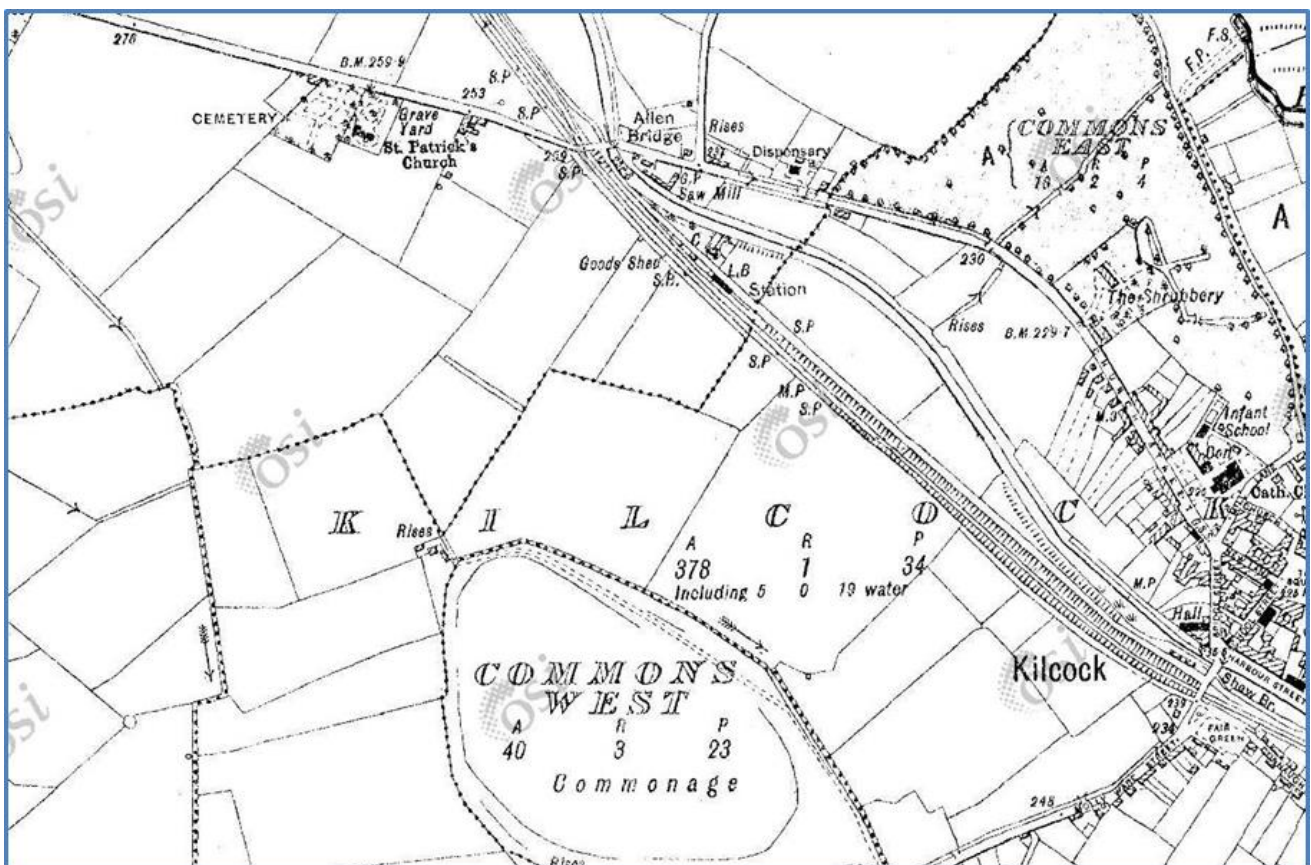
Figure 4-1 Historic 6" OS Mapping

- Historical Ordnance Survey OS maps for the subject site do not show any indicators of flood risk. Figure 4-1 shows the historic 6" OS mapping for the Study Area.

- There are no significant watercourses within the subject site. Fig. 4.2 shows schematically the site topography. The site comprises two high points, with the existing ground level falling steadily away from these high points. The downslope from these high points meets to form a channel at the narrowest part of the site, with the ground falling eastwards from this channel and away from the site. Immediately downstream from this location, a stream rises at the western end of the Commons and flows eastwards therefrom, away from the subject site (this rising is shown on the OS map in Fig. 4.1).

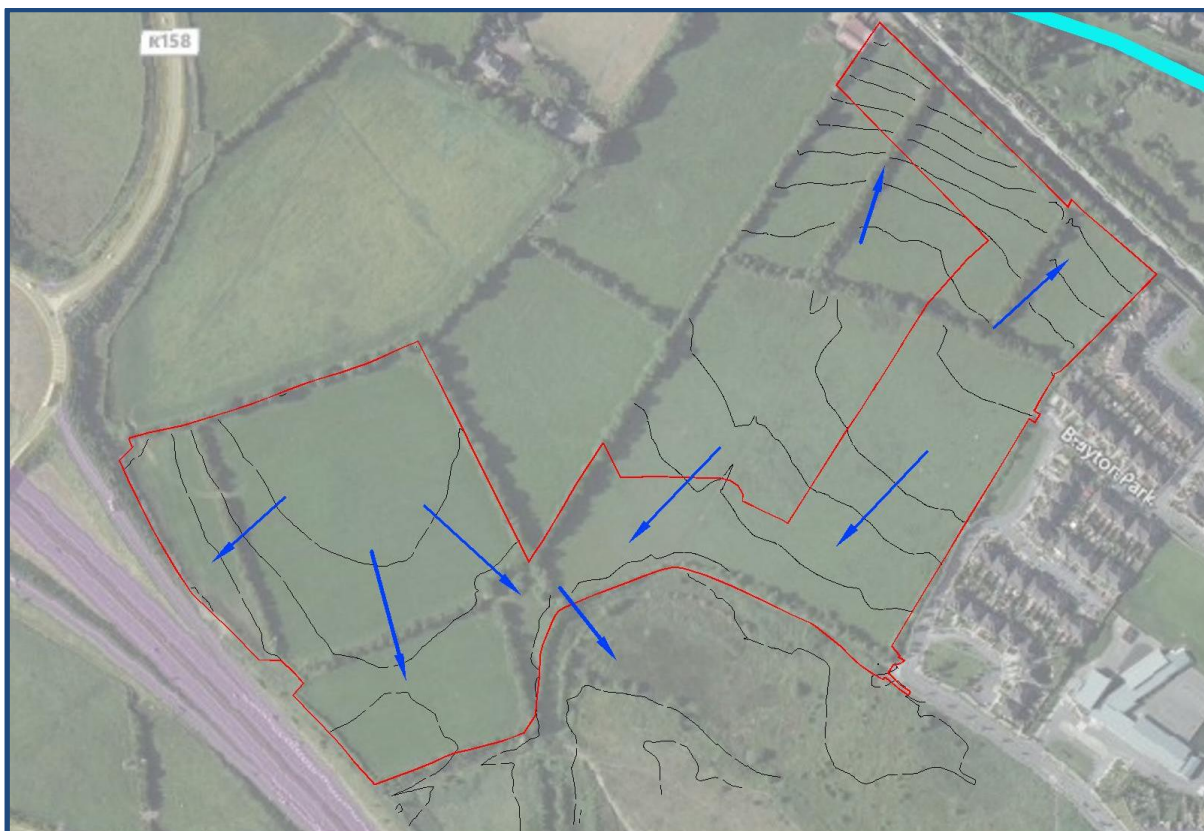
Figure 4-2 Site Topography

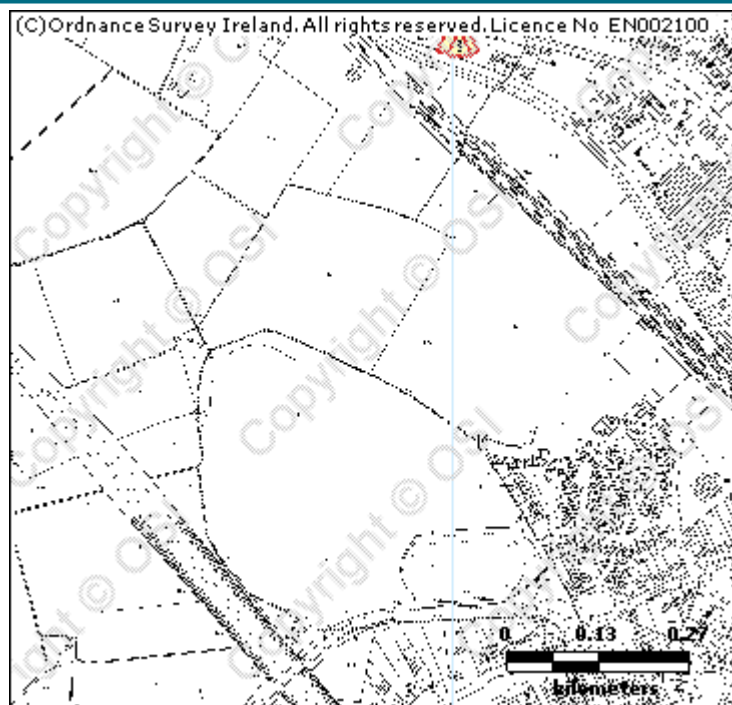
Map Scale 1:11,132

Summary report from OPW Flood Hazard Website

- The OPW maintains the National Flood Hazard Mapping website which contains information about locations that may be at risk from flooding. The source of this information includes Local Authorities and other historic records such as newspaper articles and other documentation about reported floods. There is no evidence of any recorded flood events at the subject Site (a copy of the summary report is included in Appendix B);

- Records from the National Flood Hazard Mapping website maintained by the OPW do not contain any evidence of flood events at the Site associated with pluvial flooding (refer to Appendix B);

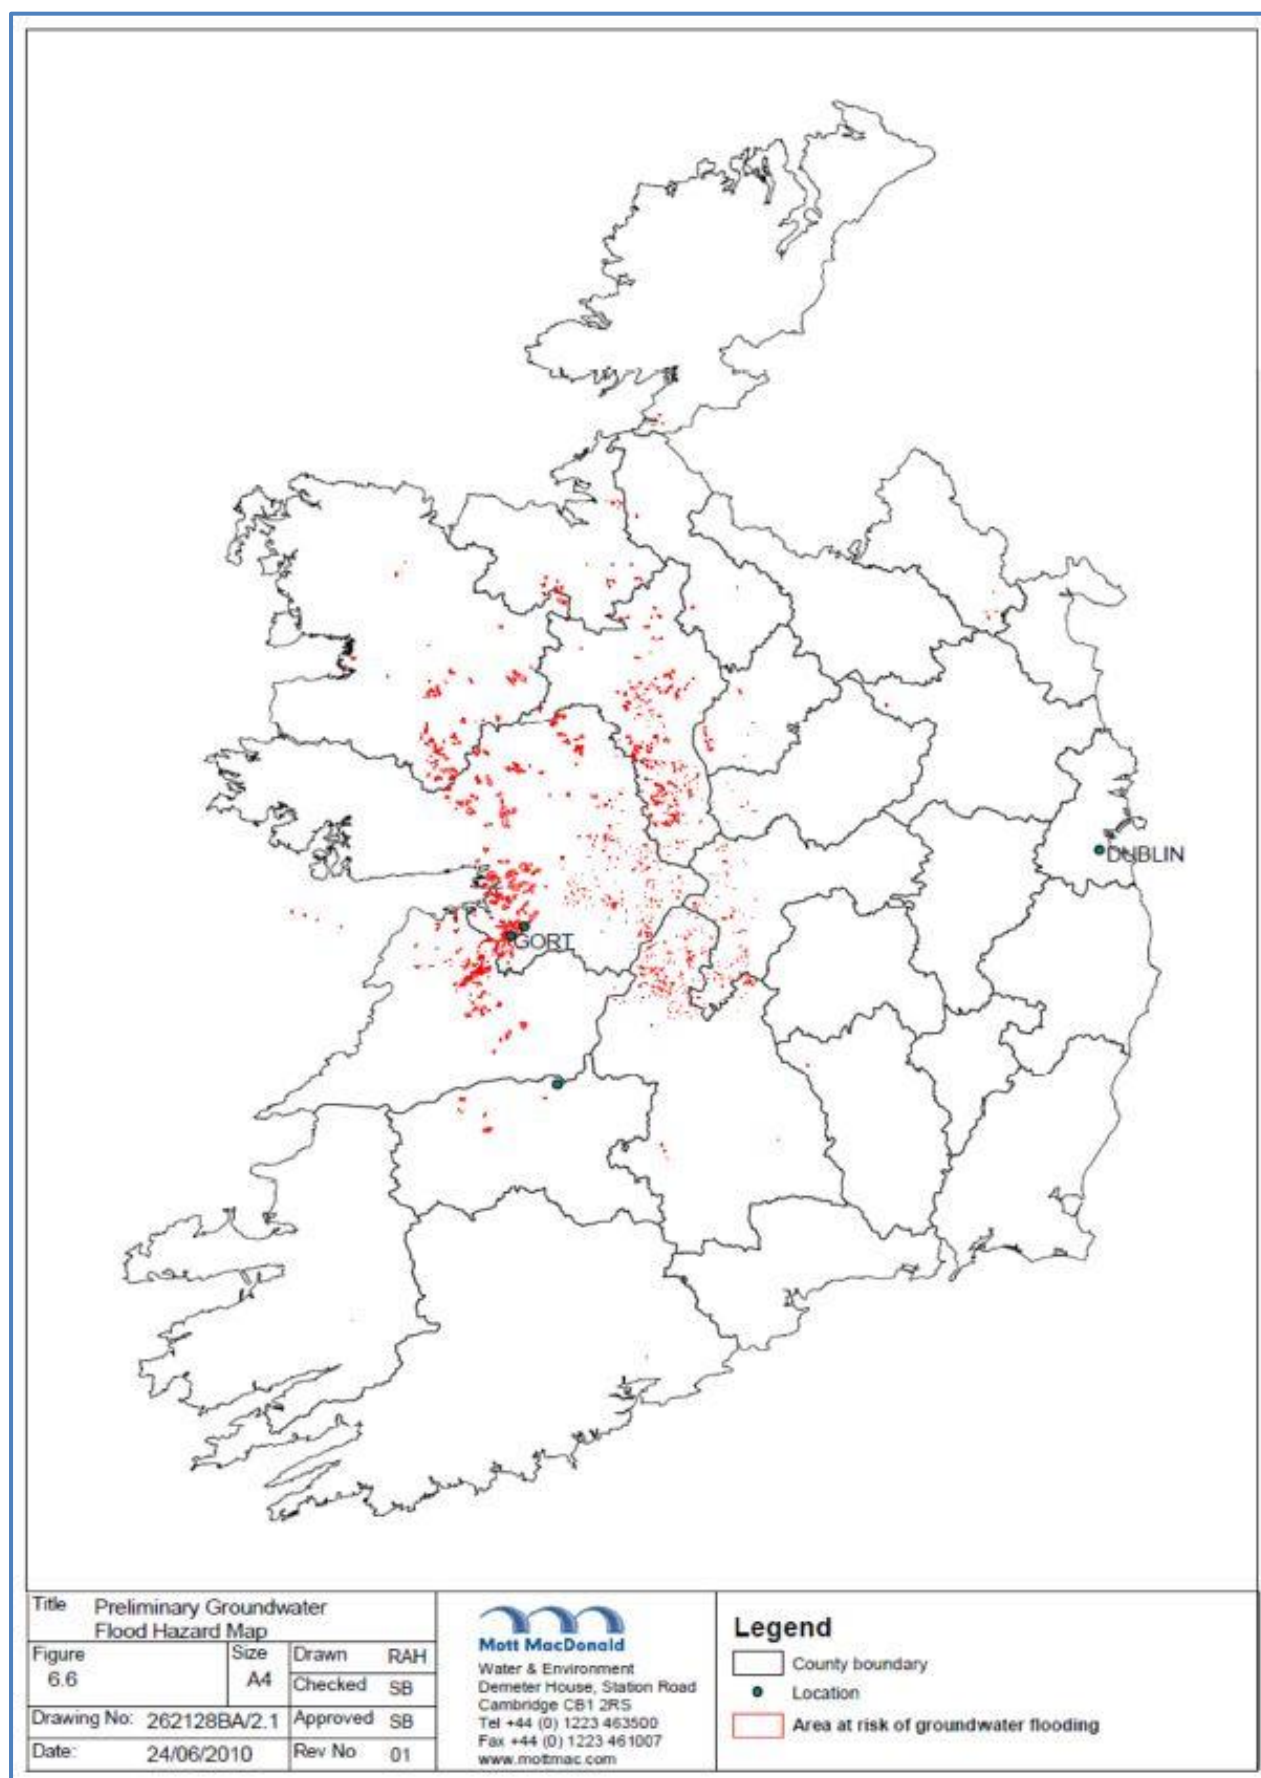
Appendix E
OPW Preliminary Flood Risk Assessments
Groundwater Flooding Map

- OPW Preliminary Flood Risk Assessments Groundwater Flooding Report concludes that ground water flooding is largely confined to the West Coast of Ireland, due to the hydrogeology of the area. The map indicates that groundwater flooding is not considered a risk in this area of County Kildare. Refer Appendix E for the Groundwater Flood Hazard map.

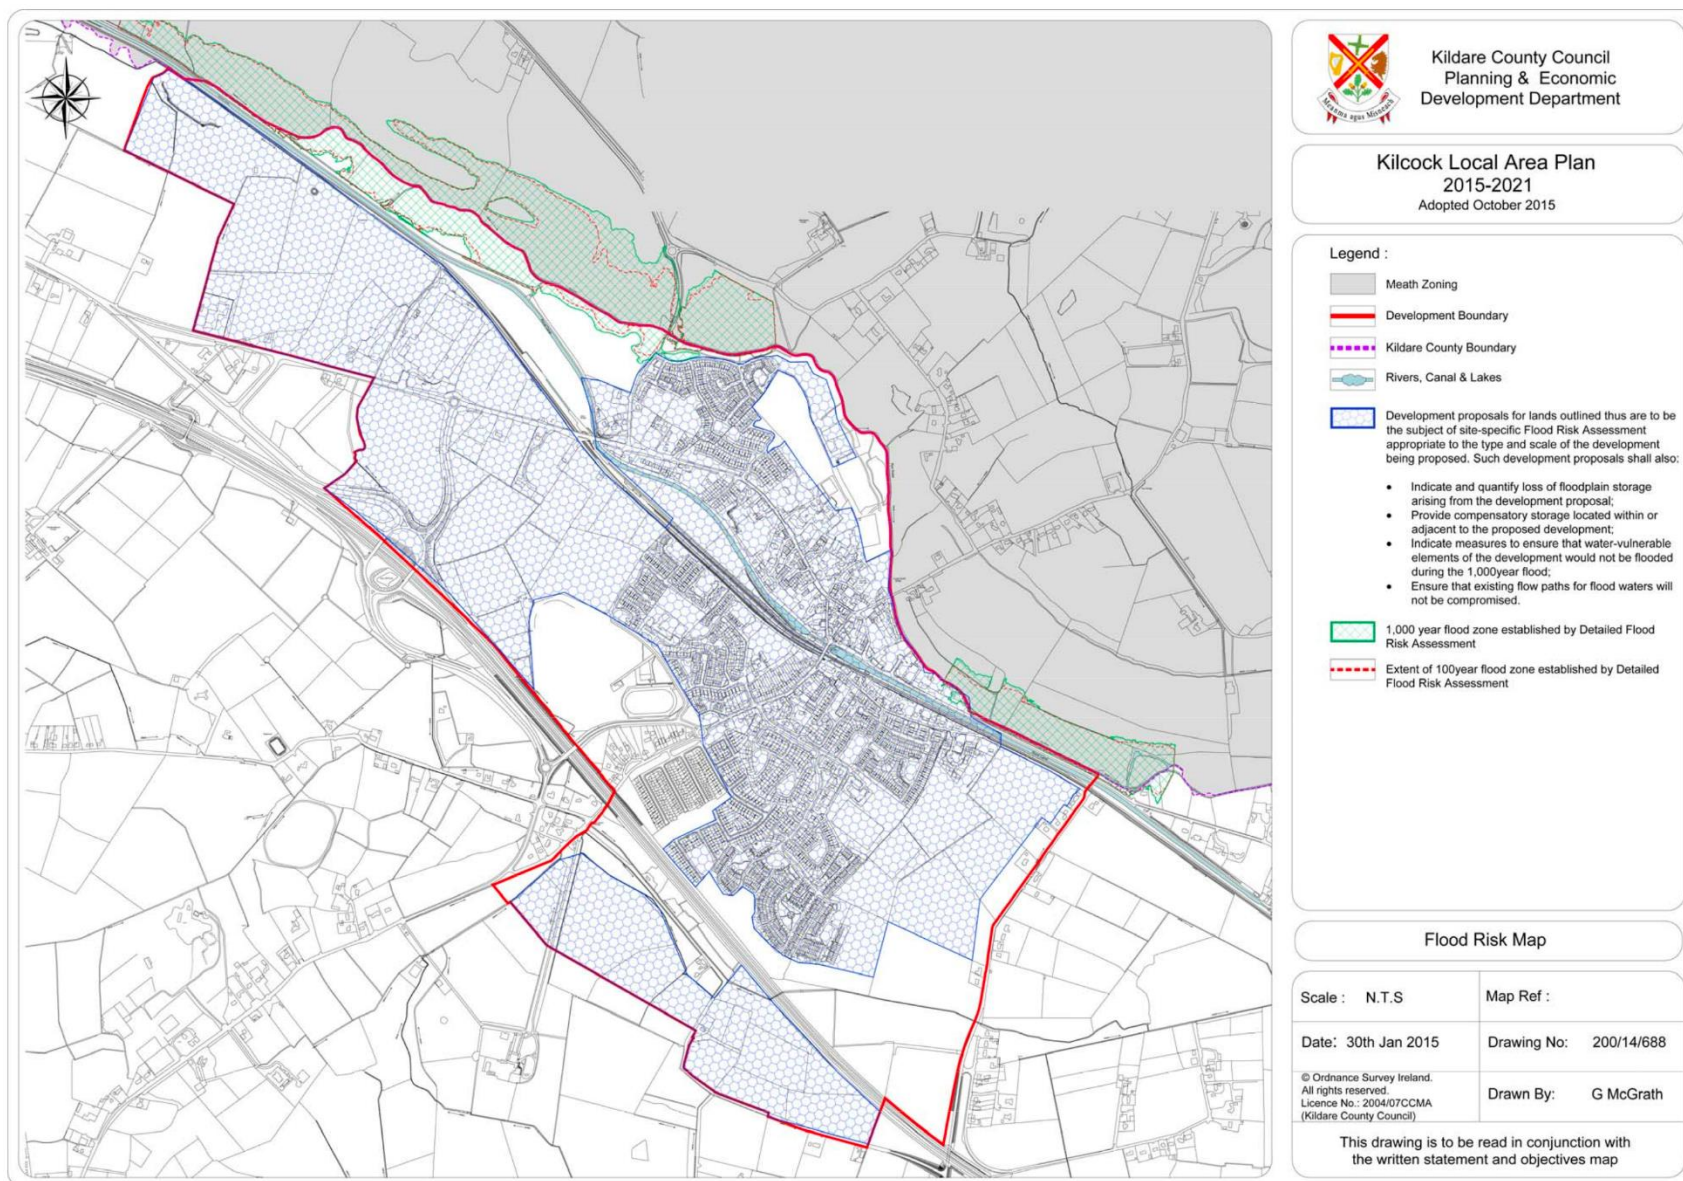
Map 8 – Flood Risk, Kilcock LAP 2015 - 2021

The Strategic Flood Risk Assessment for the Kilcock Local Area Plan 2015 to 2021 does not detail any instances of historic or current flood risk within the vicinity of the Site. The Strategic Flood Risk Assessment identified areas where initial assessment indicated a possible risk of minor localised flooding and recommended that proposals to develop these lands be subject to SSFRA, this SSFRA to be appropriate to the nature and scale of the development being proposed. These areas are shown on Map 8 of the Kilcock LAP. This map shows the subject site to be within an area for which SSFRA of development proposals is recommended.
