Project Title: Longview Estate Development

Drawing Title: Neighbourhood 1 - Stormwater/Foul

Client: Longview Estates Ltd.

Designed: SM	Drawn: SM	Checked: KM
Scale: 1:500 @ A1 1:1000 @ A3	Date: Nov 2019	
Job No: 17066HD	Drawing No: LHD_F1_P01	Revision:

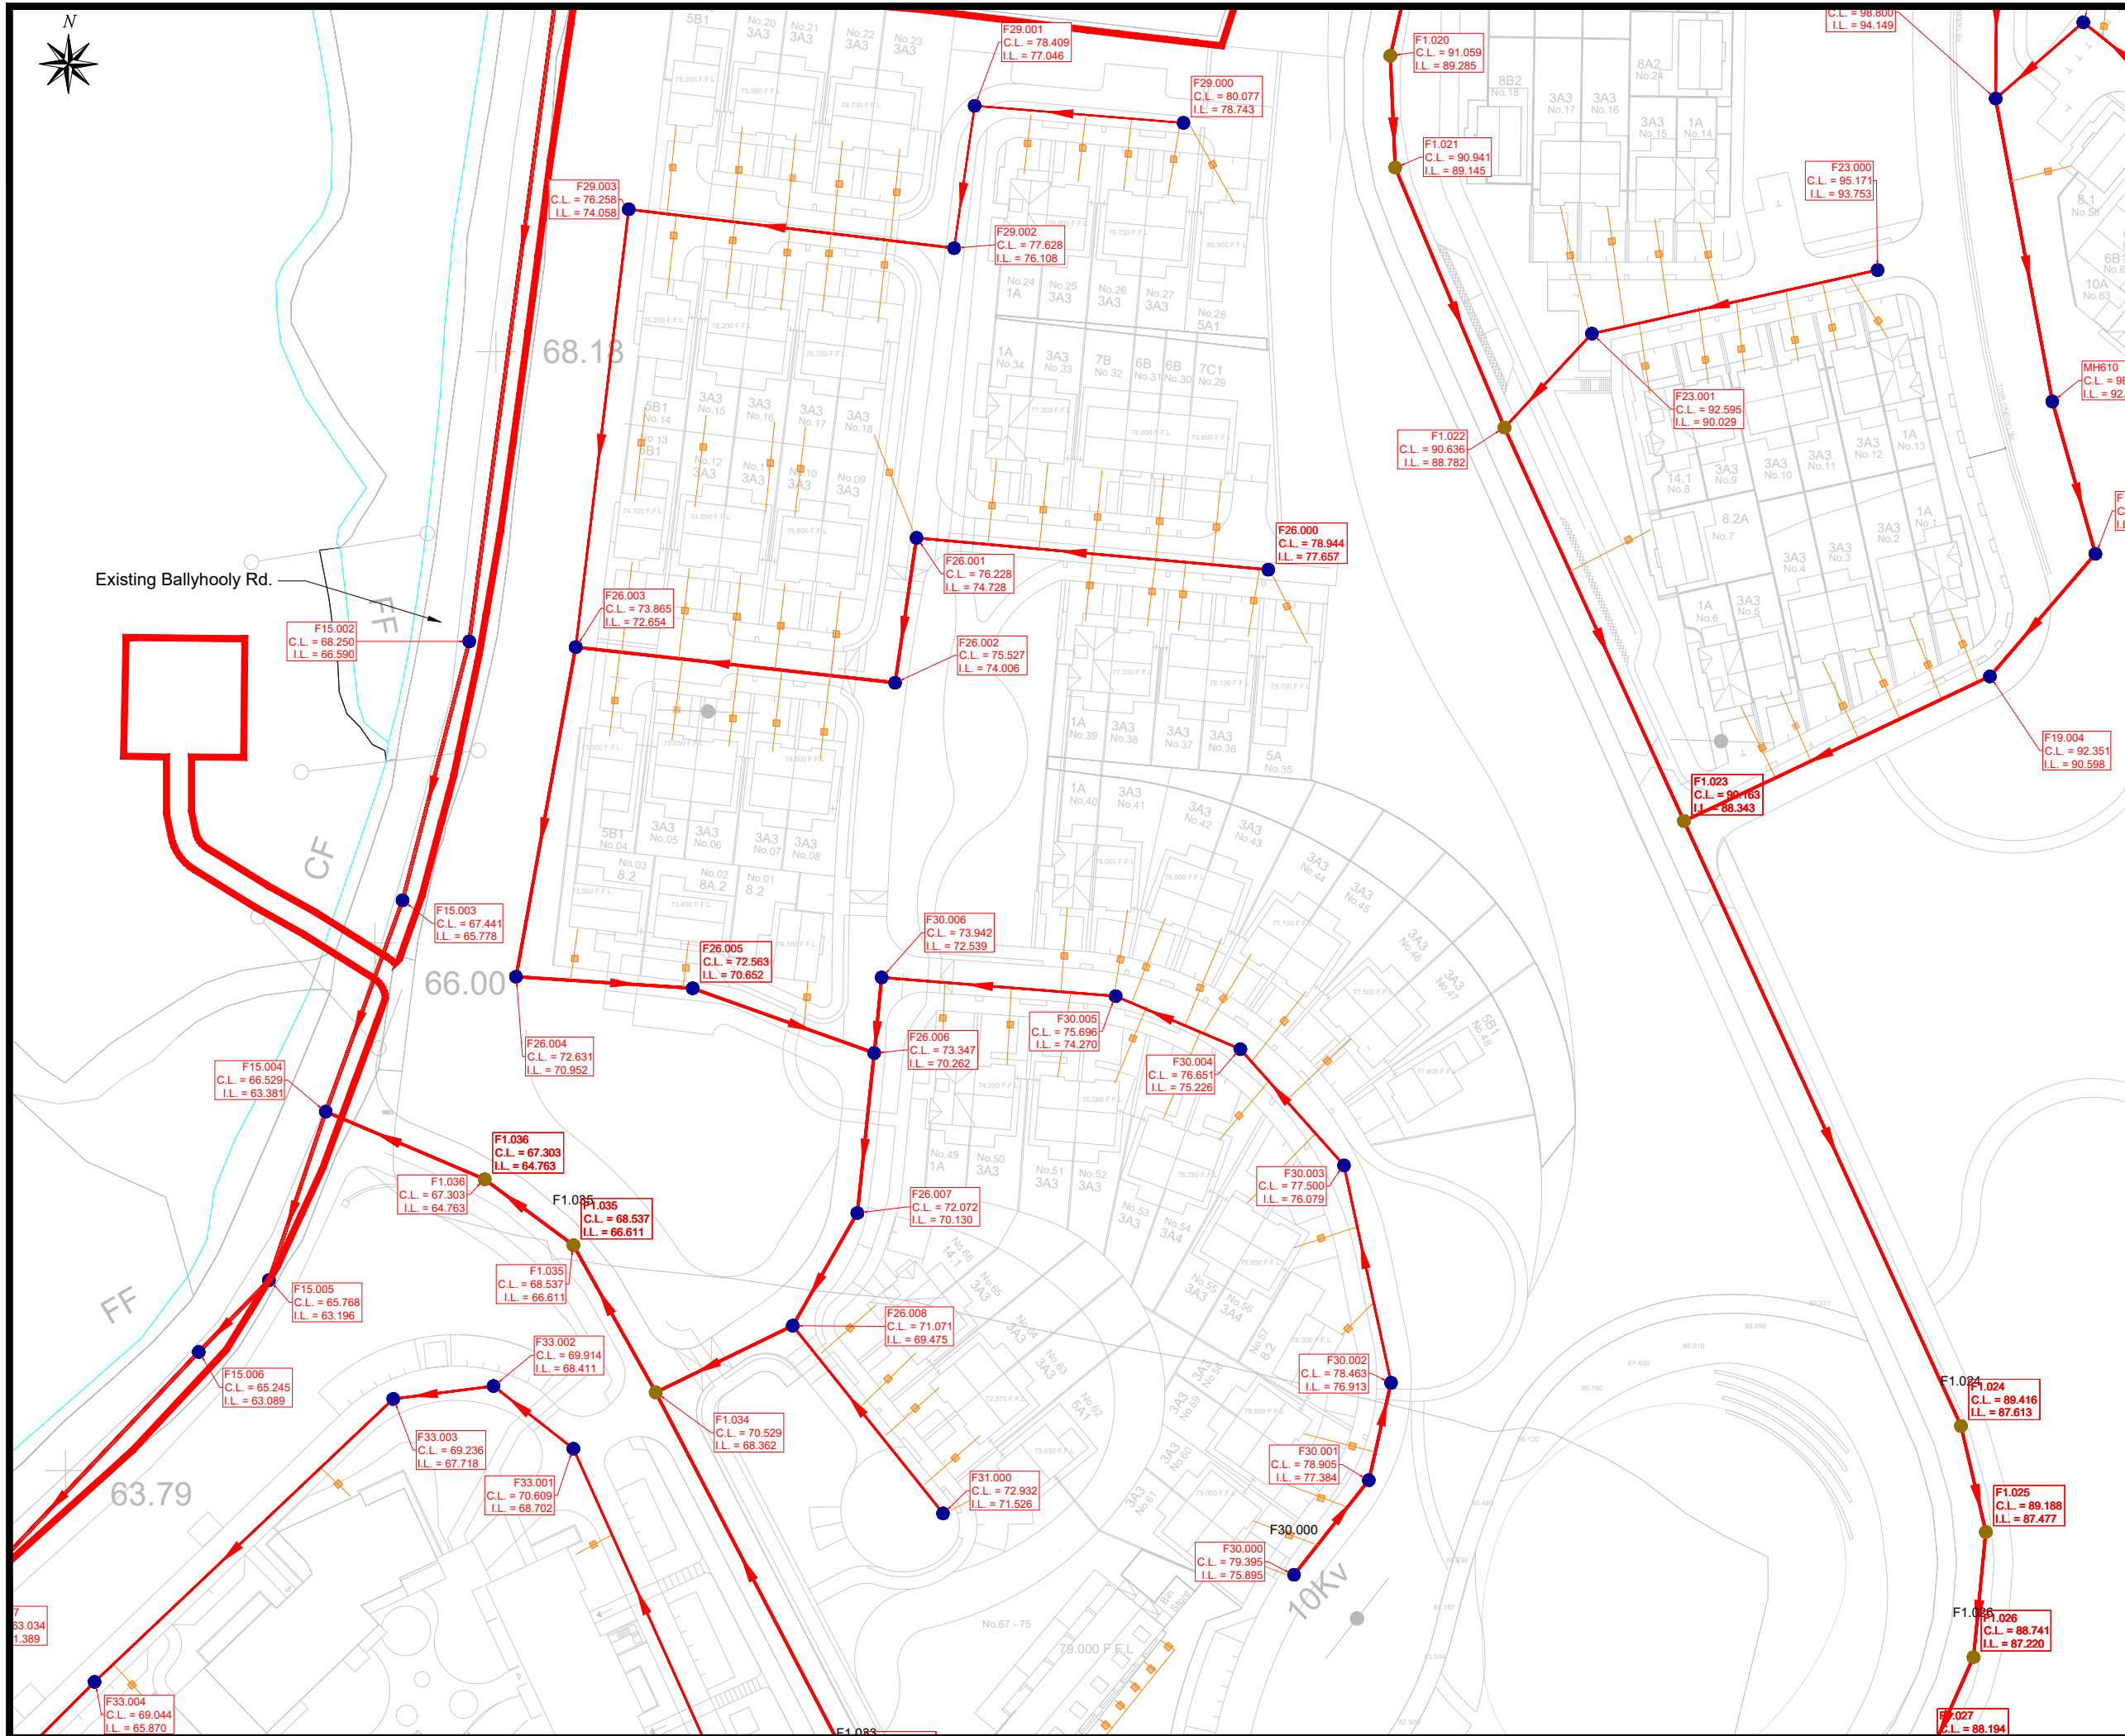
Gravity sewer pipe material to be concrete in accordance with Irish Water Wastewater Code of Practice, section 3.13.1
